Country Hills Manor

Level 1 Reserve Study

Report Period – 06/01/2018 – 5/31/2019

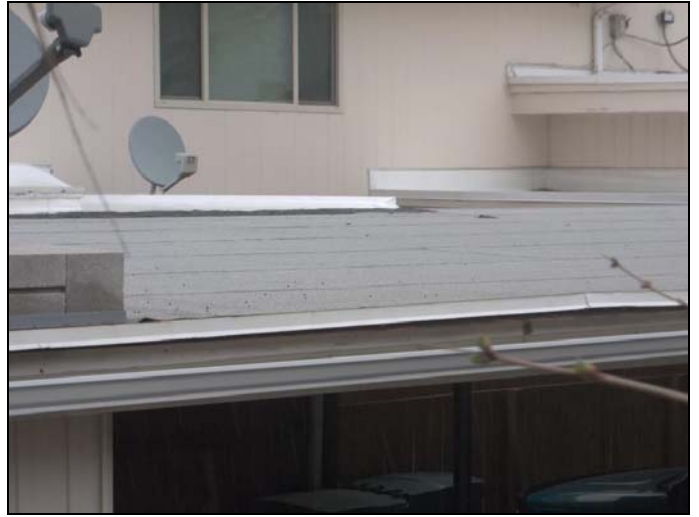
Comp #: 104 Flat Roofs - 1994 - Replace

Location: **Community Carports**

Unable to fully inspect this component at the time of the site visit. We recommend funding to replace this component approximately every 20 - 25 years. Remaining life based on current age.

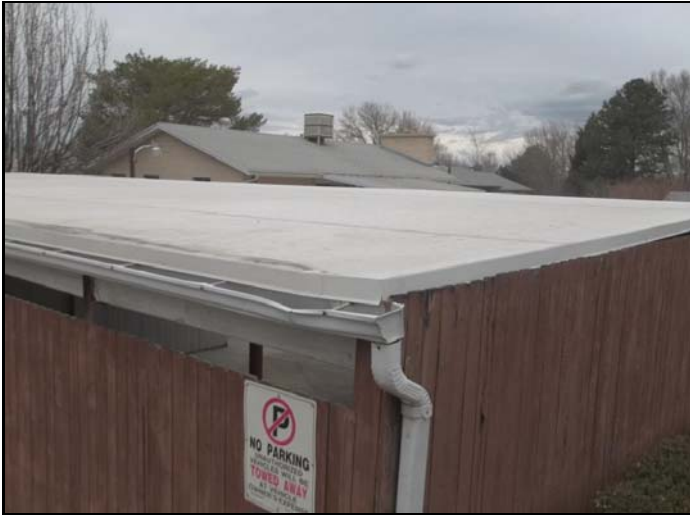
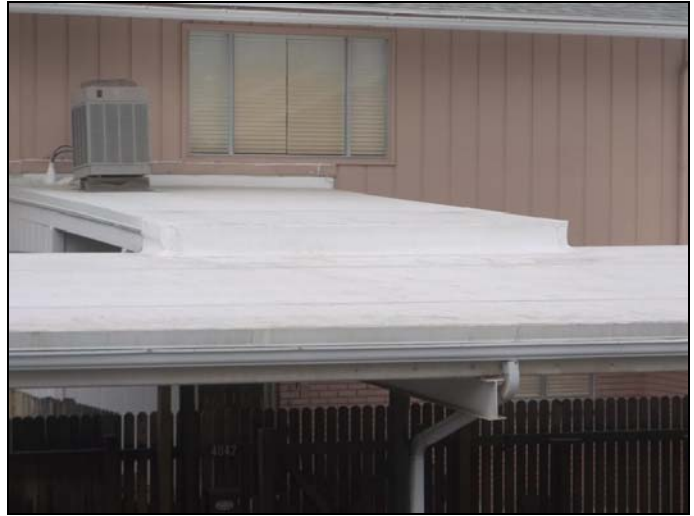
Comp #: 104 Flat Roofs - 2003 - Replace

Location: **Community Carports**

Unable to fully inspect this component at the time of the site visit. We recommend funding to replace this component approximately every 20 - 25 years. Remaining life based on current age.

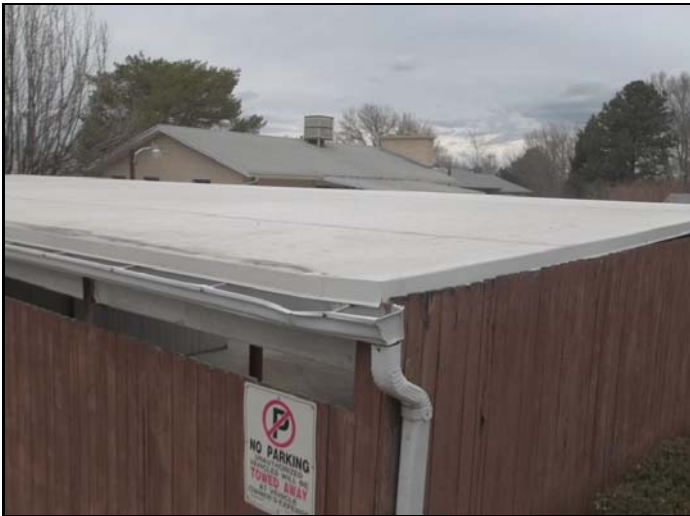
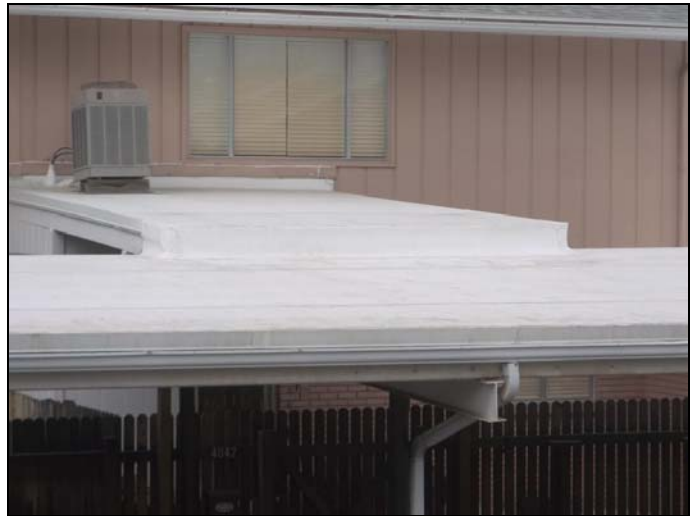
Comp #: 104 Flat Roofs - 2004-2008 - Replace

Location: **Community Carports**

Unable to fully inspect this component at the time of the site visit. We recommend funding to replace this component approximately every 20 - 25 years. Remaining life based on current age.

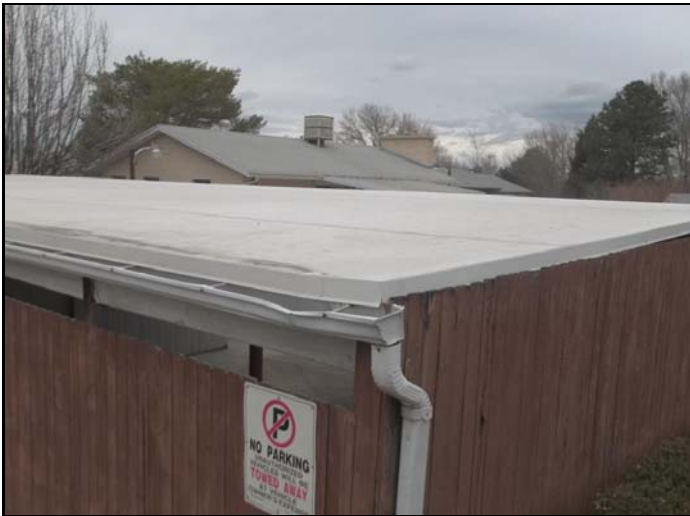
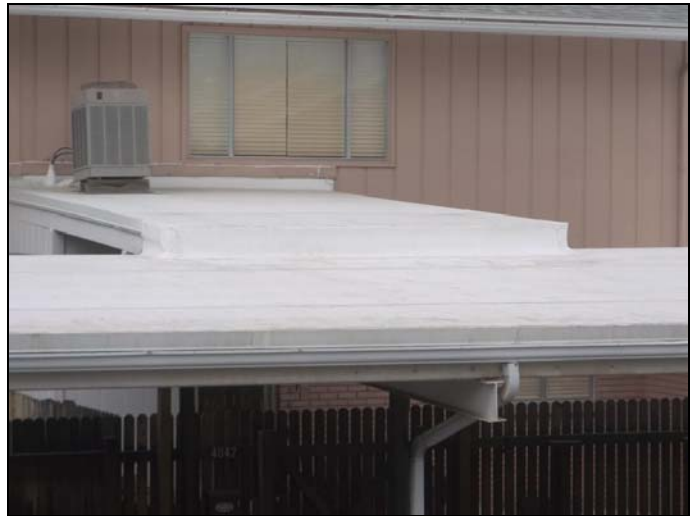
Comp #: 104 Flat Roofs - 2009-2011 - Replace

Location: **Community Carports**

Unable to fully inspect this component at the time of the site visit. We recommend funding to replace this component approximately every 20 - 25 years. Remaining life based on current age.

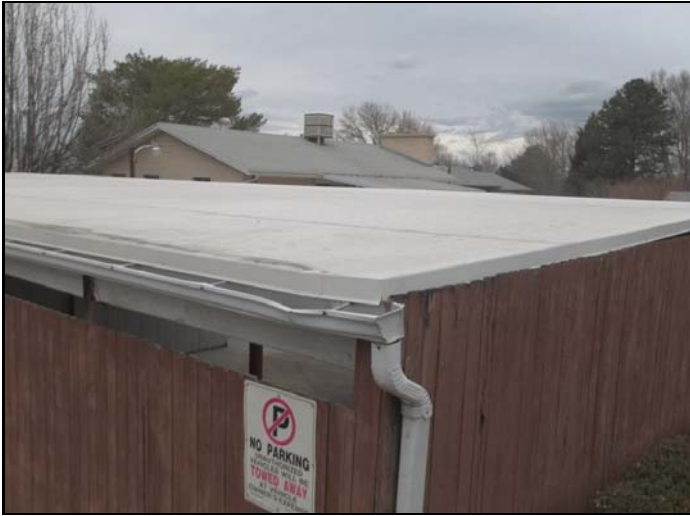
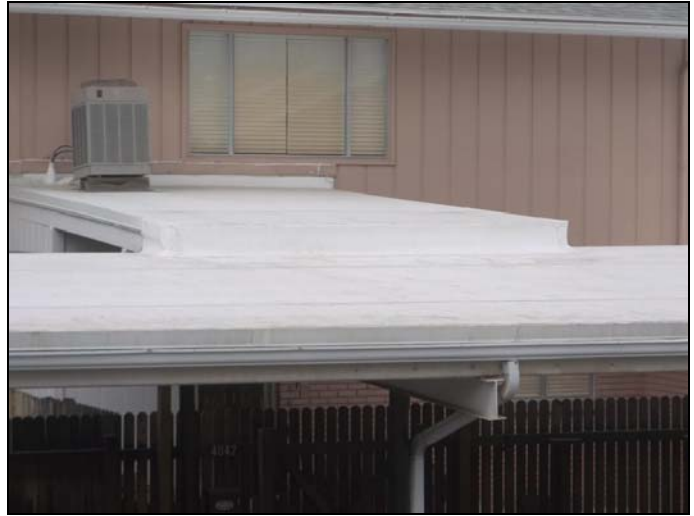
Comp #: 104 Flat Roofs - 2012-2015 - Replace

Location: **Community Carports**

Unable to fully inspect this component at the time of the site visit. We recommend funding to replace this component approximately every 20 - 25 years. Remaining life based on current age.

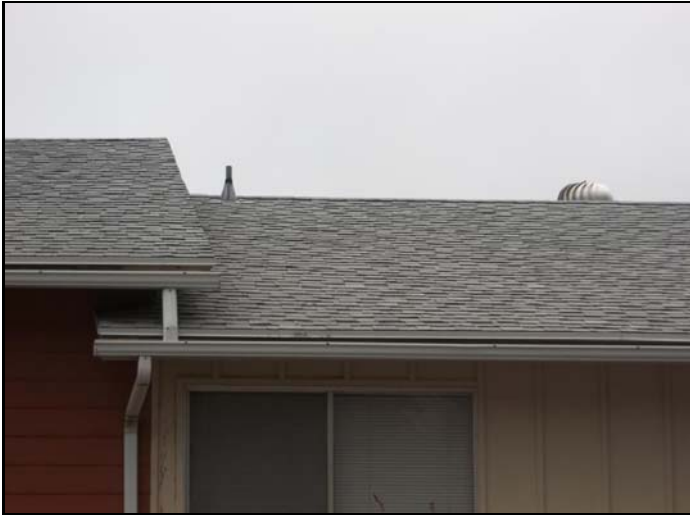
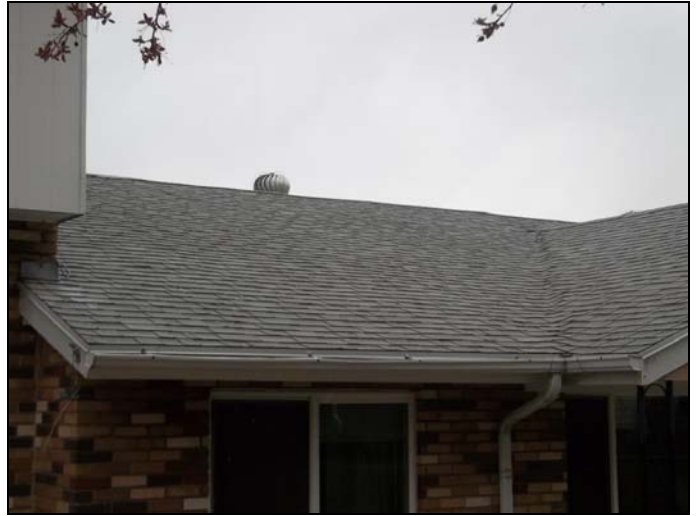
Comp #: 105 Roofs - 1998-2003 - Replace

Location: **Building Roofs**

The roofs are in fair condition. We recommend funding to replace this component approximately every 20 - 25 years. Remaining life based on average age.

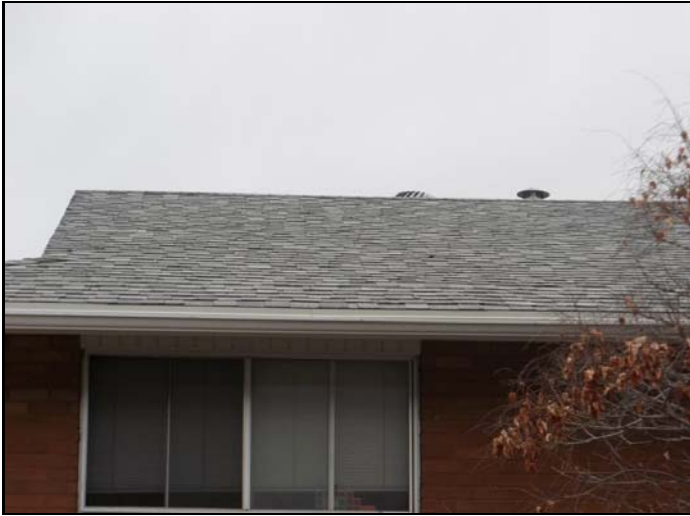
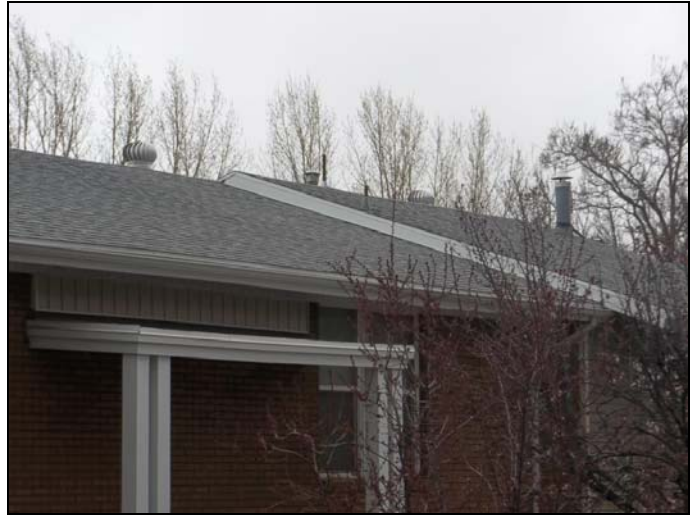
Comp #: 105 Roofs - 2004-2008 - Replace

Location: **Building Roofs**

The roofs are in good to fair condition. We recommend funding to replace this component approximately every 20 - 25 years. Remaining life based on average age.

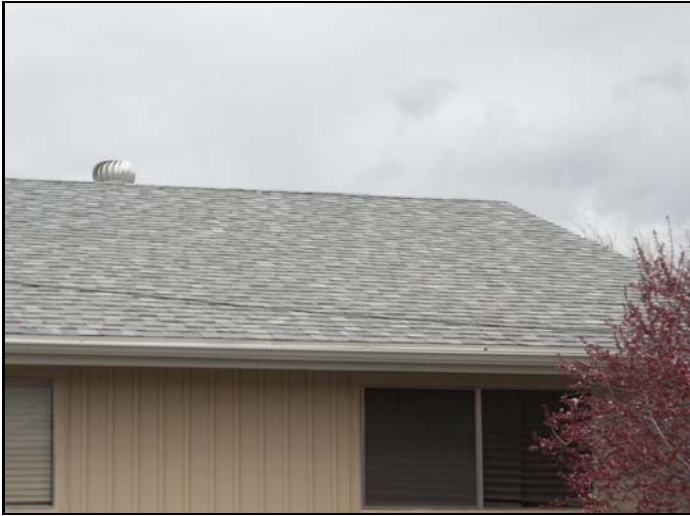
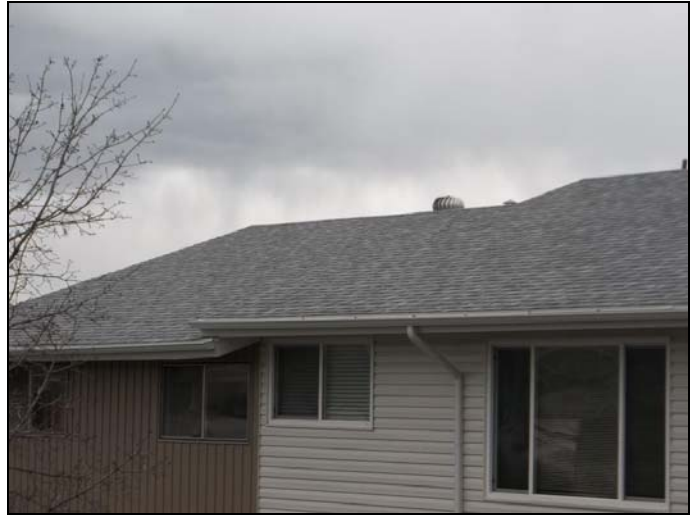
Comp #: 105 Roofs - 2009-2011 - Replace

Location: **Building Roofs**

The roofs are in good condition. We recommend funding to replace this component approximately every 20 - 25 years. Remaining life based on average age.

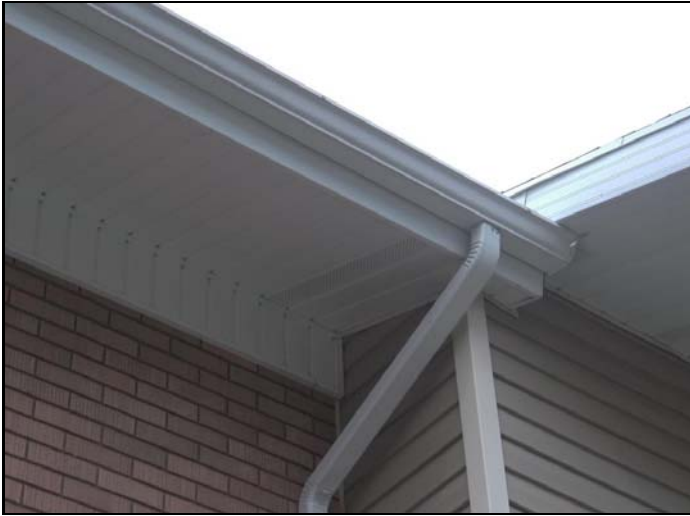
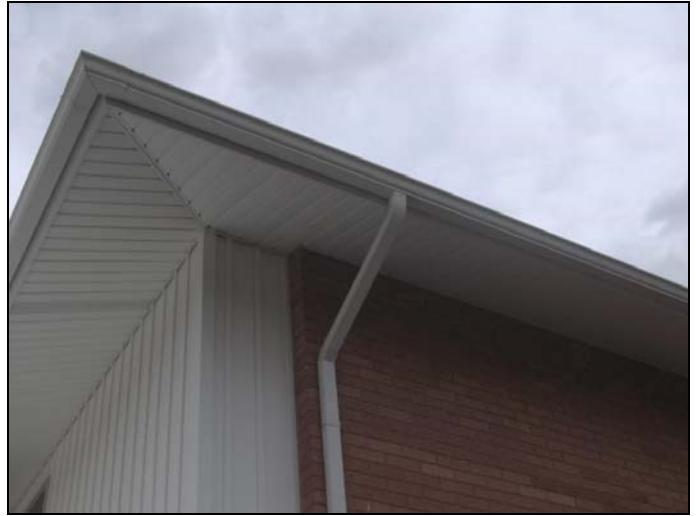
Comp #: 120 Rain Gutters/Downspouts - Replace

Location: **Building Roofs**

Research with the client reveals this component is replaced as necessary as an operating expense.

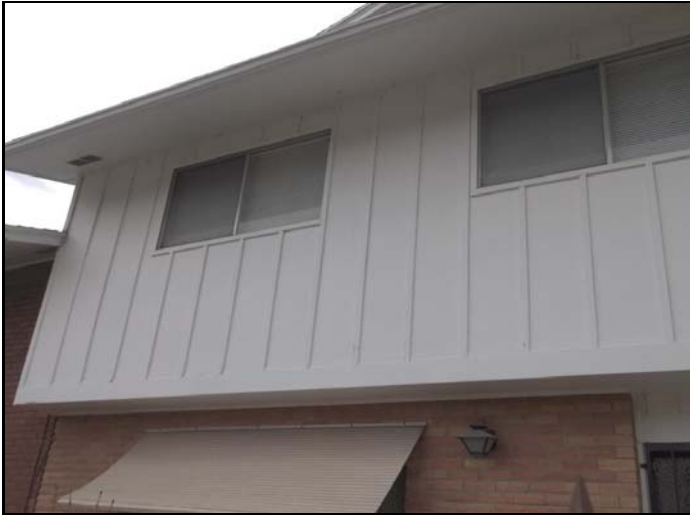
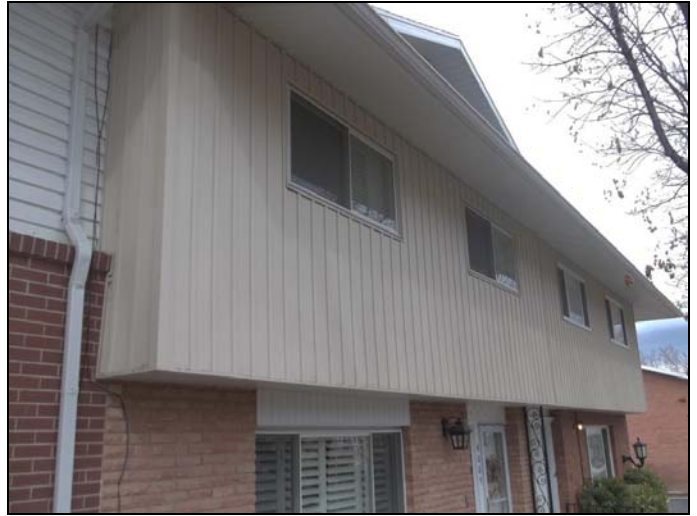
Comp #: 302 Vinyl Siding - 2013-2017 - Replace

Location: **Building Exteriors**

The vinyl siding is in good condition. Although this component may reach and extended useful life we recommend funding to replace this component approximately every 40 - 50 years to maintain appearance. Remaining life based on average age.

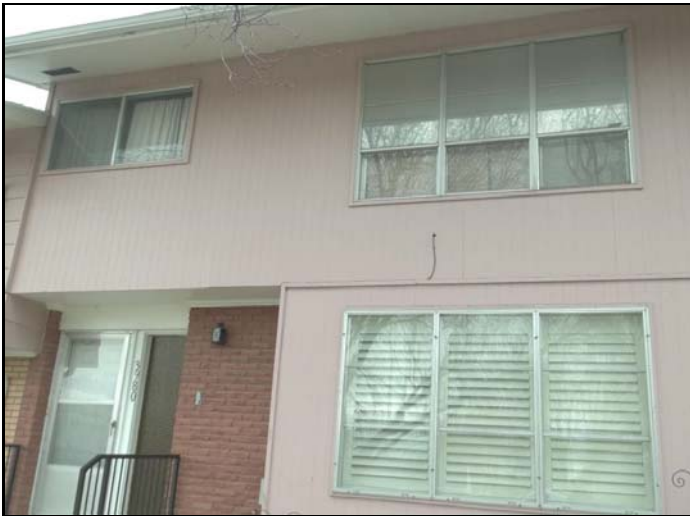
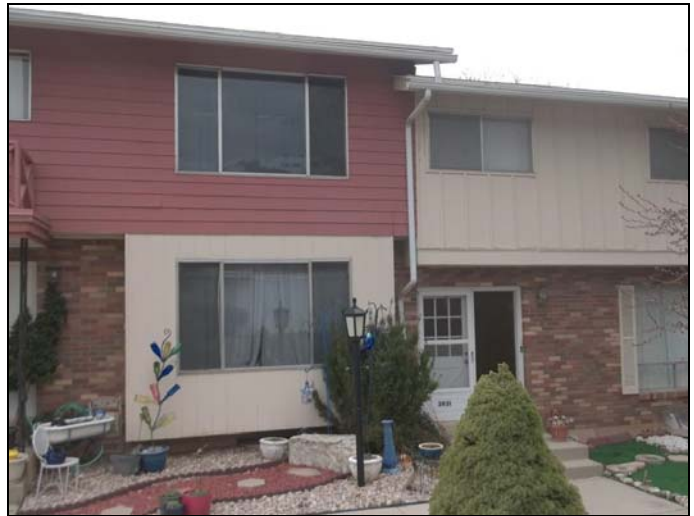
Comp #: 390 Siding - 2018-19 - Replace

Location: **Building Exteriors**

Research with the client reveals this component is being replaced with a vinyl siding product in fiscal year 2018-19. Although this component may reach and extended useful life we recommend funding to replace this component approximately every 40 - 50 years to maintain appearance. Remaining life based on current age.

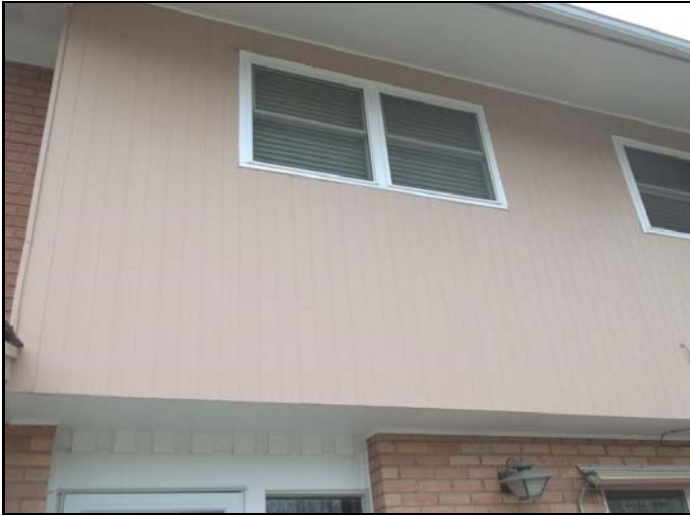
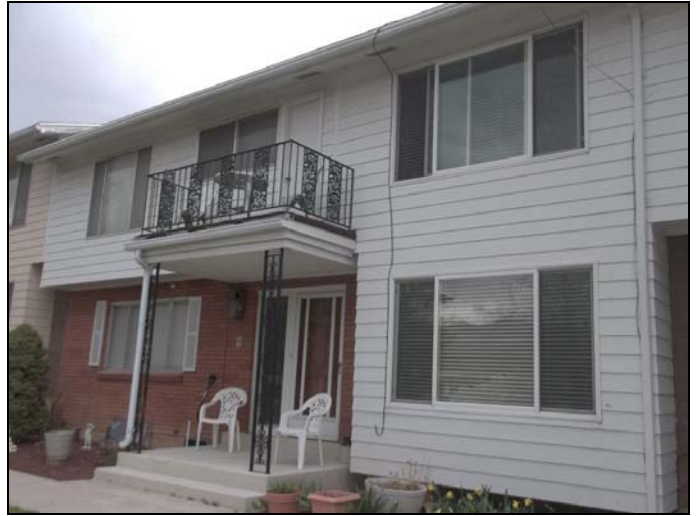
Comp #: 390 Siding - 2021-22 - Replace

Location: **Building Exteriors**

Research with the client reveals this component is being replaced with a vinyl siding product in fiscal year 2020-21. Although this component may reach and extended useful life we recommend funding to replace this component approximately every 40 - 50 years to maintain appearance. Remaining life based on current age.

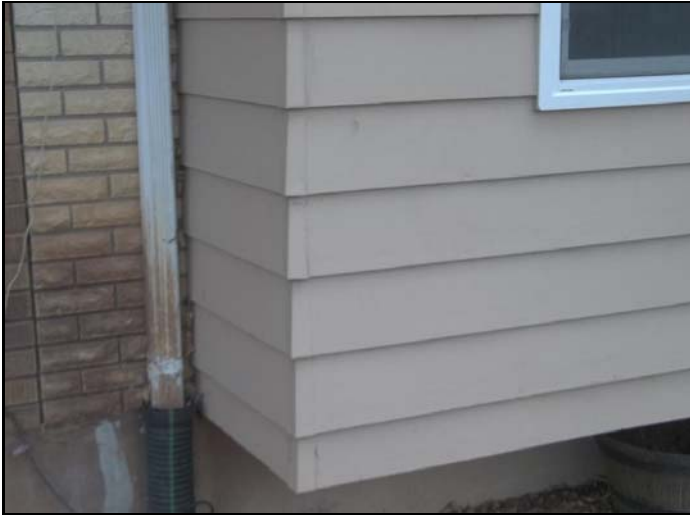
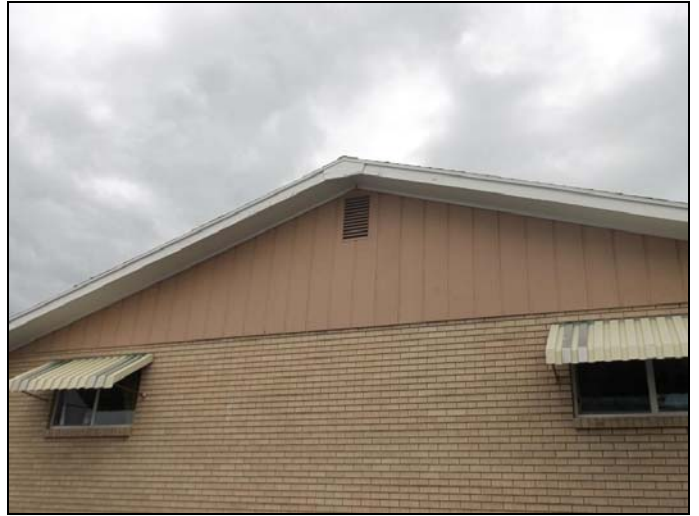
Comp #: 390 Siding - 2022-23 - Replace

Location: **Building Exteriors**

Research with the client reveals this component is being replaced with a vinyl siding product in fiscal year 2022-23. Although this component may reach and extended useful life we recommend funding to replace this component approximately every 40 - 50 years to maintain appearance. Remaining life based on current age.

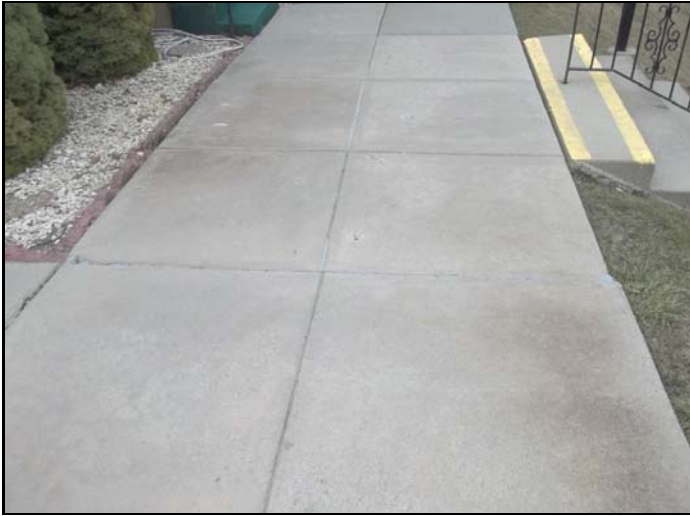
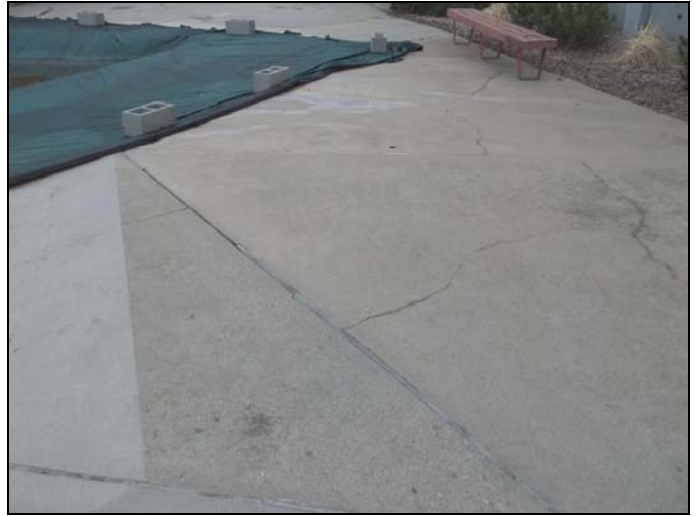
Comp #: 403 Concrete - Repair/Replace

Location: **Common Area**

The concrete is generally in fair condition. This component has an extended useful life under normal conditions. We recommend funding to make repairs and partially replace this component approximately every 10 years. Remaining life based on current condition.

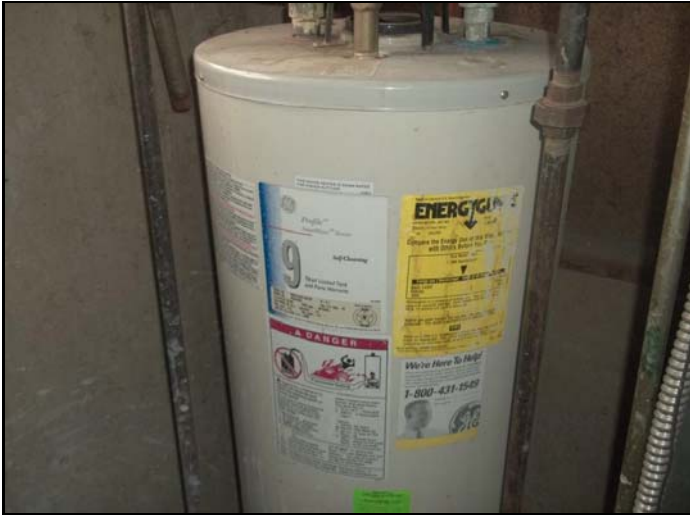
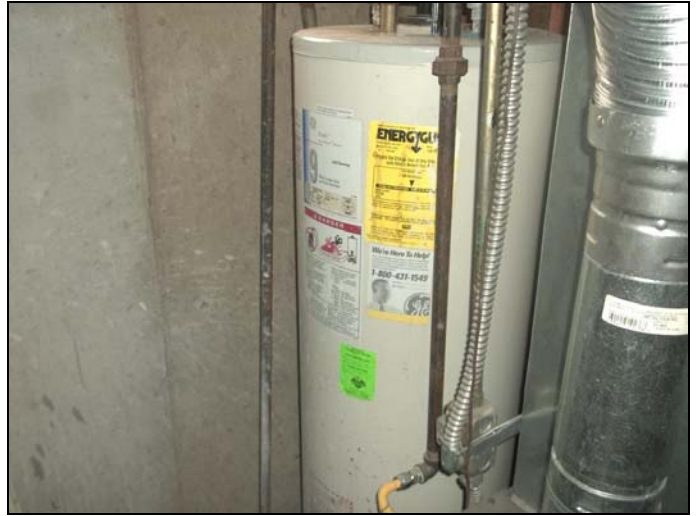
Comp #: 703 Water Heater - Replace

Location: Clubhouse Basement

The water heater is in working condition. We recommend funding to replace this component approximately every 12 years. Remaining life based on current age.

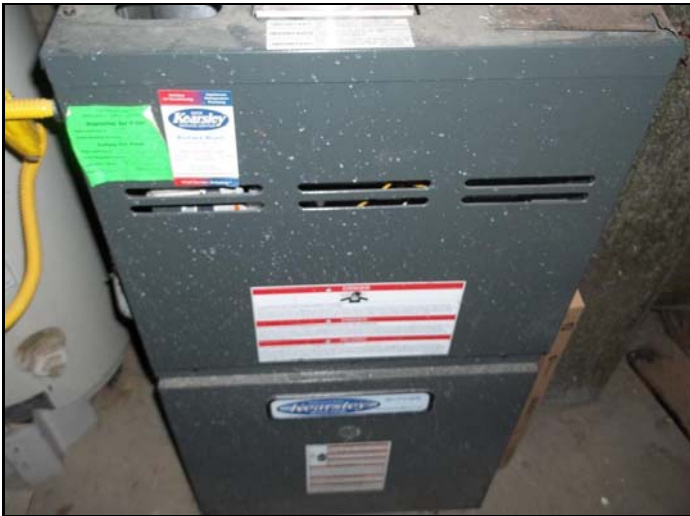
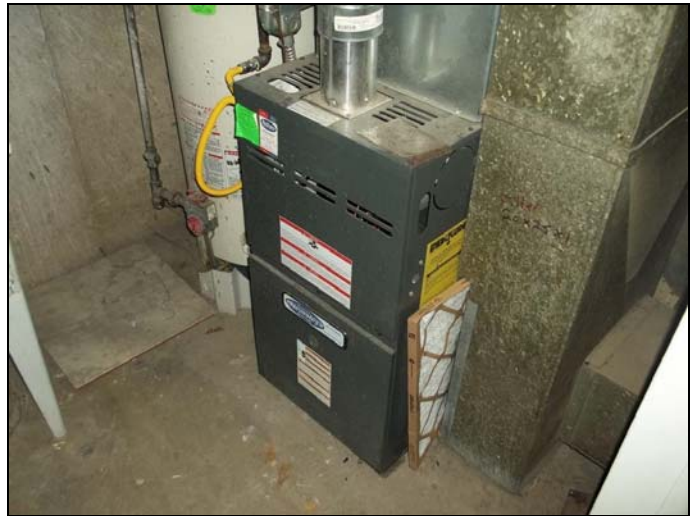
Comp #: 706 HVAC Furnace - Replace

Location: **Clubhouse Basement**

The furnace is in working condition. We recommend funding to replace this component approximately every 20 years. Remaining life based on current age.

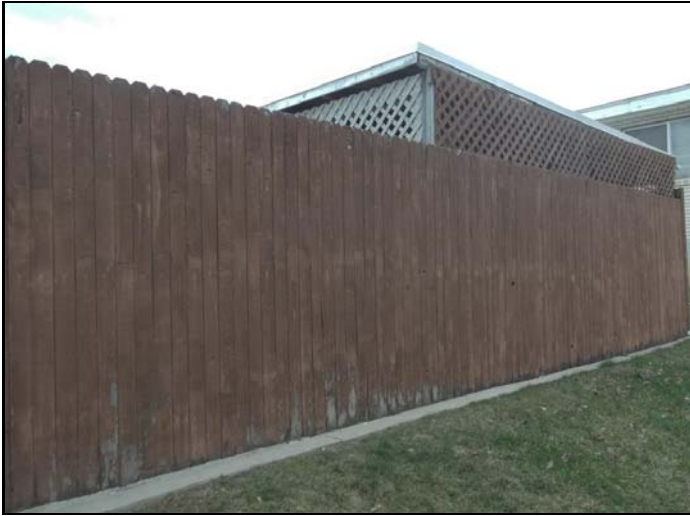
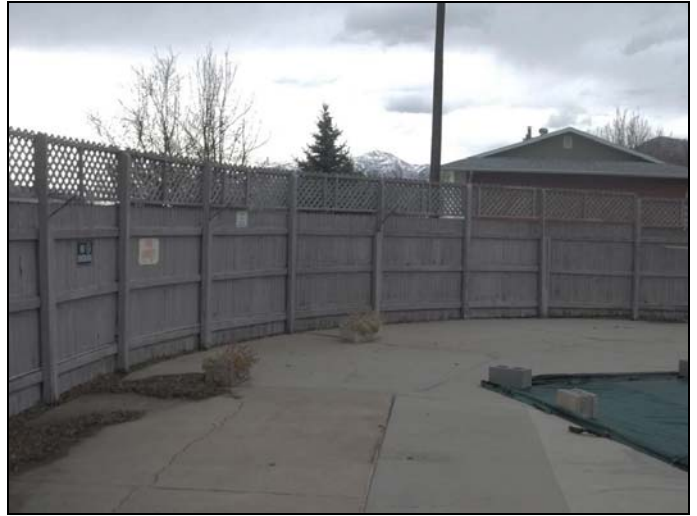
Comp #: 1001 Wood Fencing - Common - Replace

Location: **Community Perimeter & Pool Areas**

The wood fencing is in fair to poor condition. The useful life and cost information used for this component is based on replacing the wood fencing with a vinyl fencing. We recommend funding to replace this component approximately every 25 - 30 years. Remaining life based on current condition.

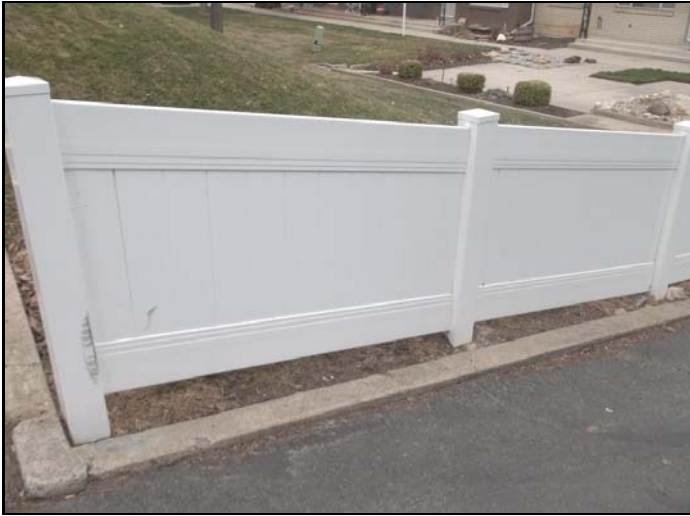
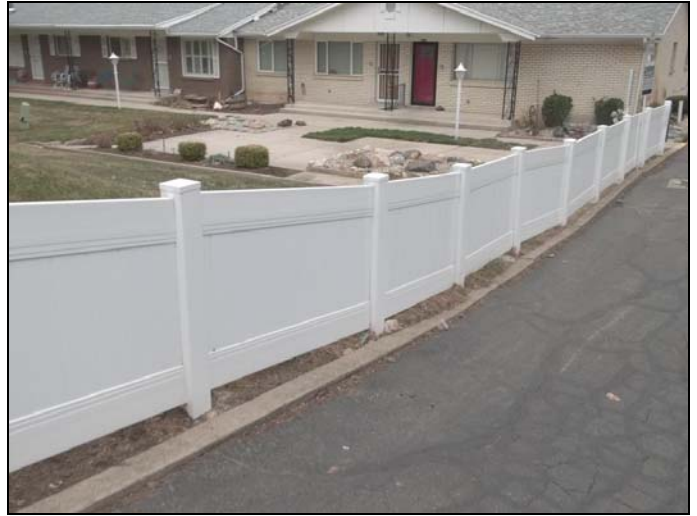
Comp #: 1008 Vinyl Fencing - Replace

Location: **Common Area**

The vinyl fencing is in good condition. We recommend funding to replace this component approximately every 25 - 30 years. Remaining life based on current age.
