Sandalwood Cove HOA

Level 2 Reserve Study

Type of Study	Update w/Site Visit
Date of Property Inspection	6/7/2017
Prepared By	Dale Gifford
Analysis Method	Cash Flow
Funding Goal	Full Funding

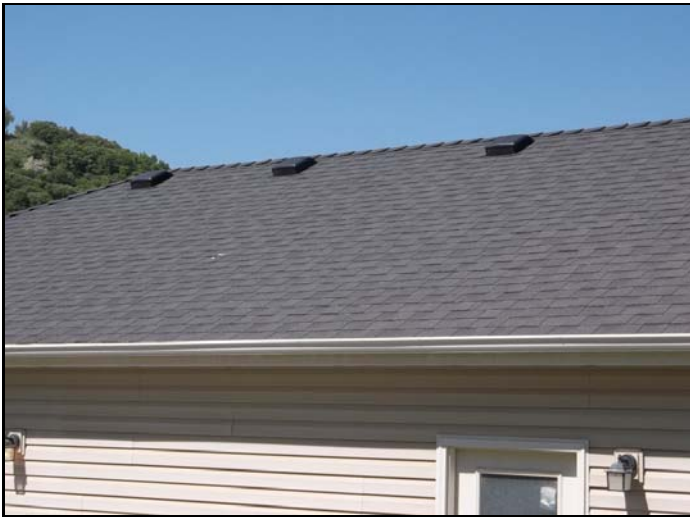
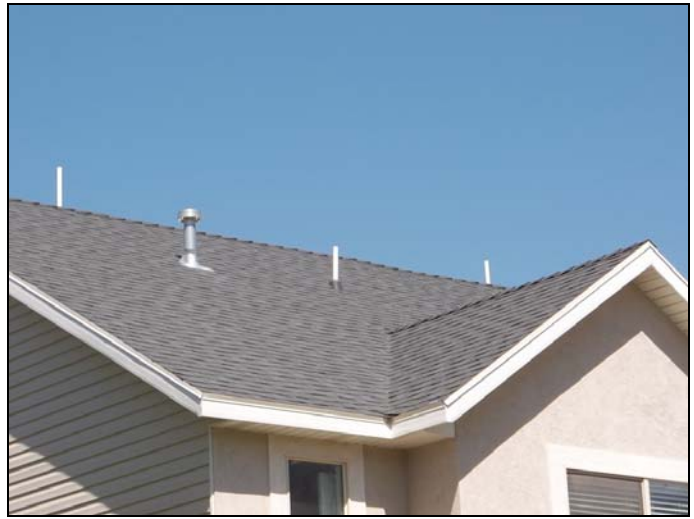
Comp #: 105 Roofs - 2002-06 - Replace

The roofs are in good condition. We recommend funding to replace this component approximately every 20 - 25 years. Remaining life based on current age.

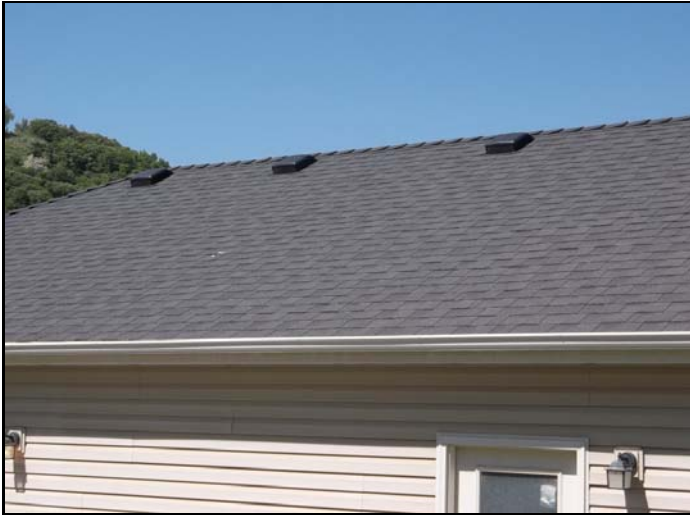
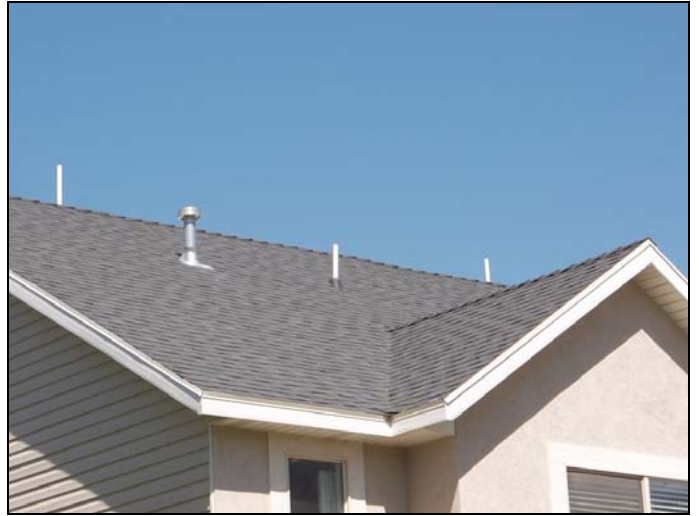
Comp #: 105 Roofs - 2007-11 - Replace

The roofs are in good condition. We recommend funding to replace this component approximately every 20 - 25 years. Remaining life based on current age.

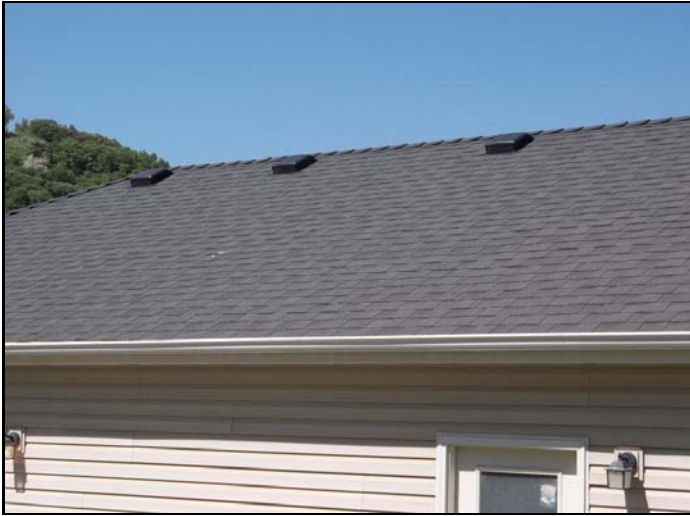
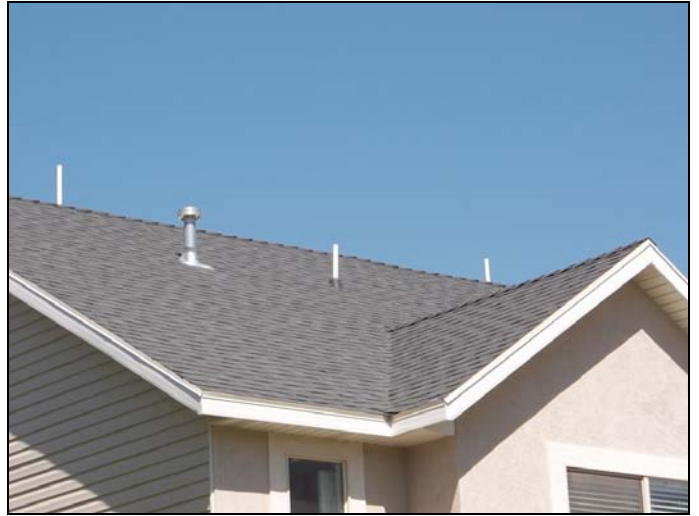
Comp #: 105 Roofs - 2012-14 - Replace

The roofs are in good condition. We recommend funding to replace this component approximately every 20 - 25 years. Remaining life based on current age.

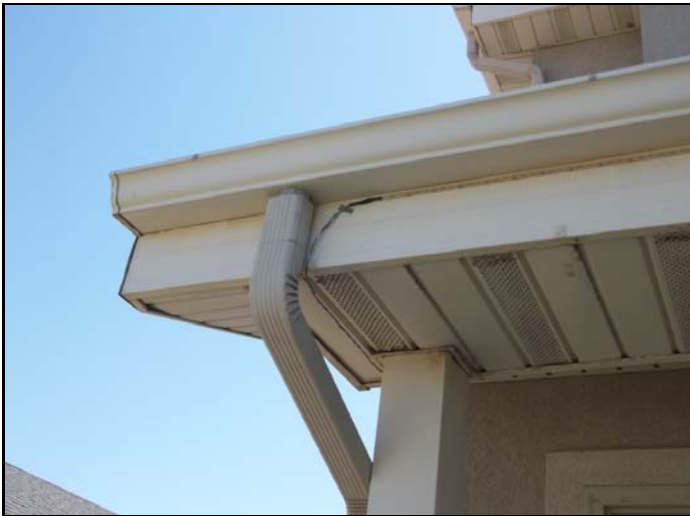
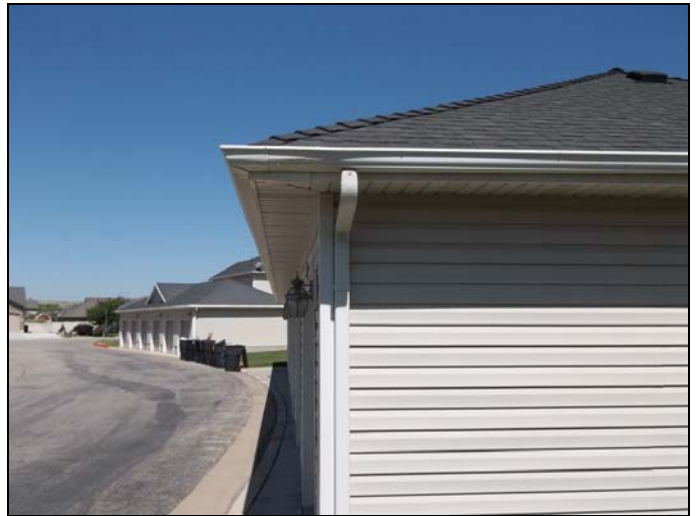
Comp #: 120 Rain Gutters/Downspouts - 2002-06 - Replace

The rain gutters and downspouts are in good condition. We recommend replacing the rain gutters and downspouts at the same time as the roof replacement (see Comp# 105 Pitched Roof - Comp Shingle - Replace) to ensure proper function and to take advantage of the cost savings benefits. We recommend funding to replace this component approximately every 25 - 30 years. Remaining life based on current age.

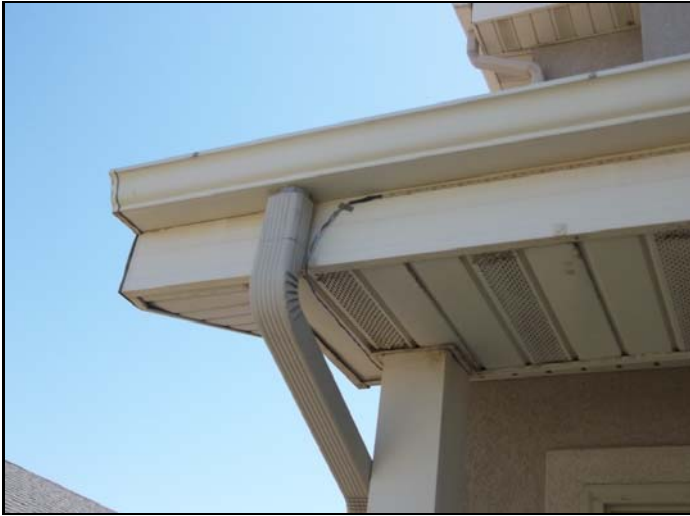
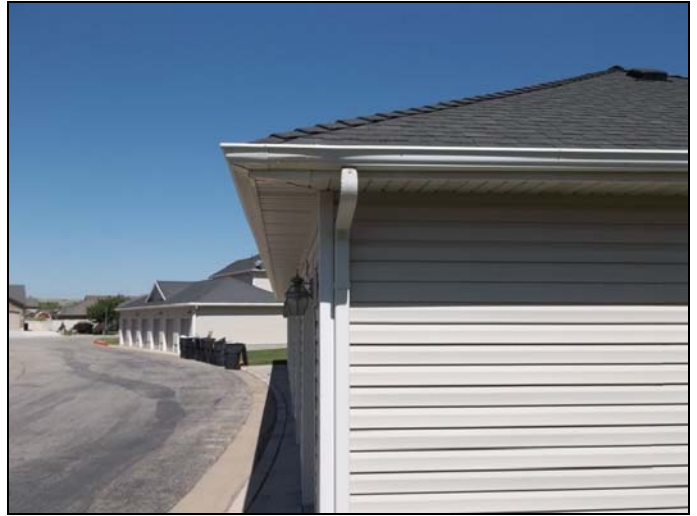
Comp #: 120 Rain Gutters/Downspouts - 2007-11 - Replace

The rain gutters and downspouts are in good condition. We recommend replacing the rain gutters and downspouts at the same time as the roof replacement (see Comp# 105 Pitched Roof - Comp Shingle - Replace) to ensure proper function and to take advantage of the cost savings benefits. We recommend funding to replace this component approximately every 25 - 30 years. Remaining life based on current age.

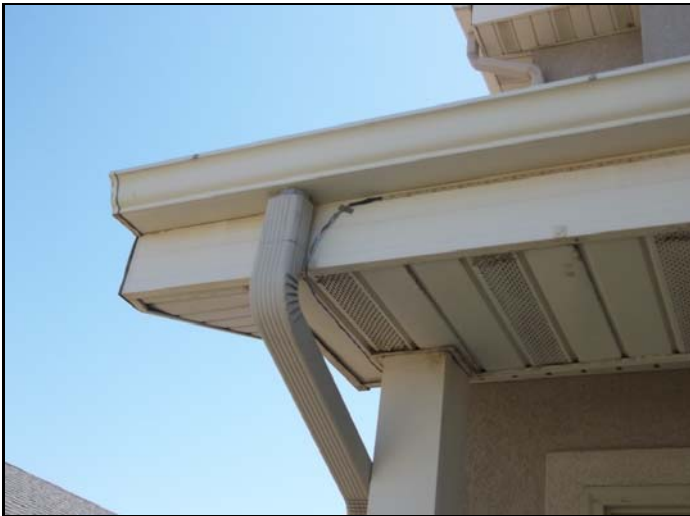
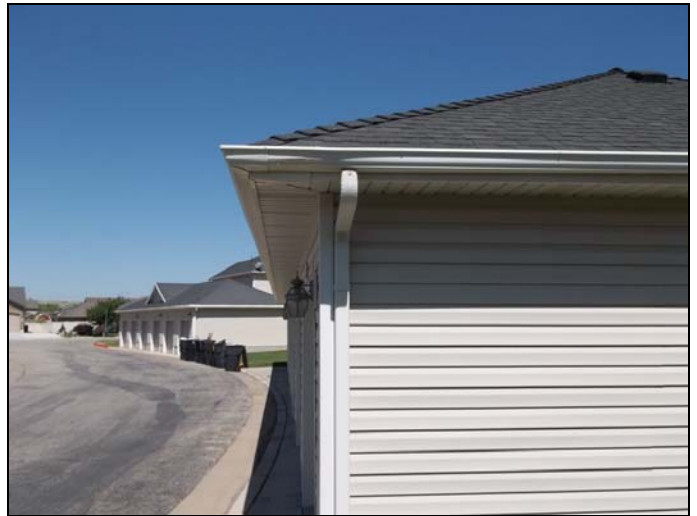
Comp #: 120 Rain Gutters/Downspouts - 2012-14 - Replace

The rain gutters and downspouts are in good condition. We recommend replacing the rain gutters and downspouts at the same time as the roof replacement (see Comp# 105 Pitched Roof - Comp Shingle - Replace) to ensure proper function and to take advantage of the cost savings benefits. We recommend funding to replace this component approximately every 25 - 30 years. Remaining life based on current age.

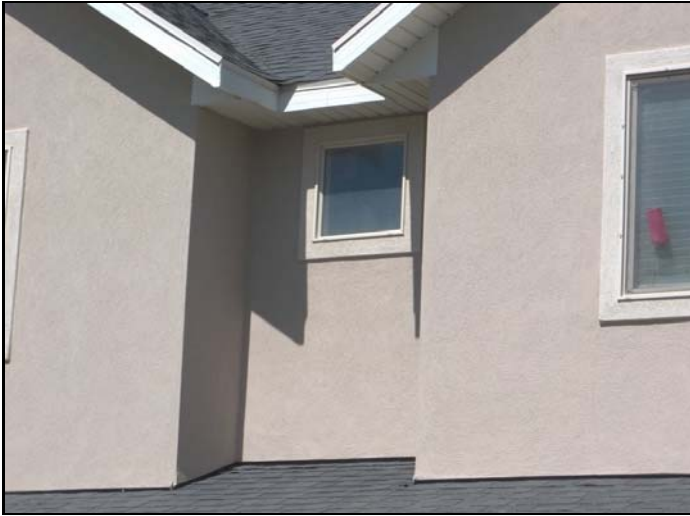
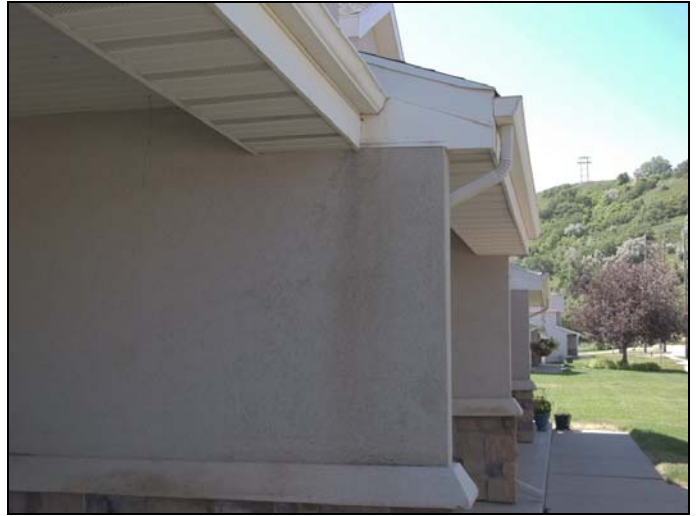
Comp #: 201 Stucco Surfaces - 2002-06 - Repair/Repaint

The stucco surfaces are in good to fair condition. Minor damage and discoloration were noted at the time of the inspection. We recommend funding to repair/repaint this component approximately every 12 - 15 years to protect the stucco surface and maintain appearance. Remaining life based on current age.

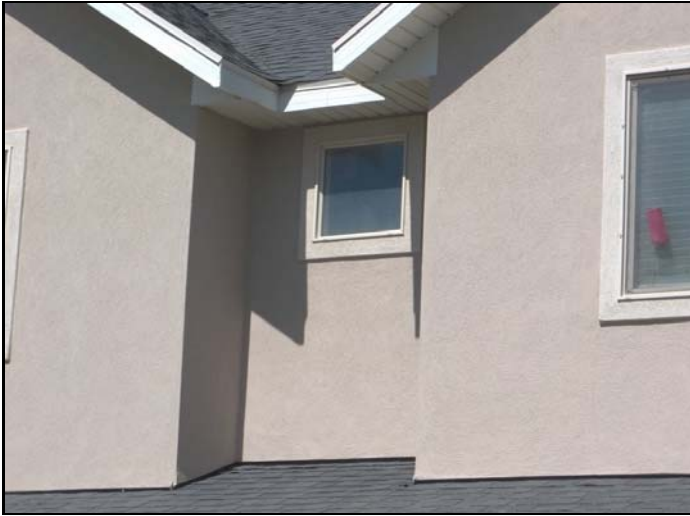
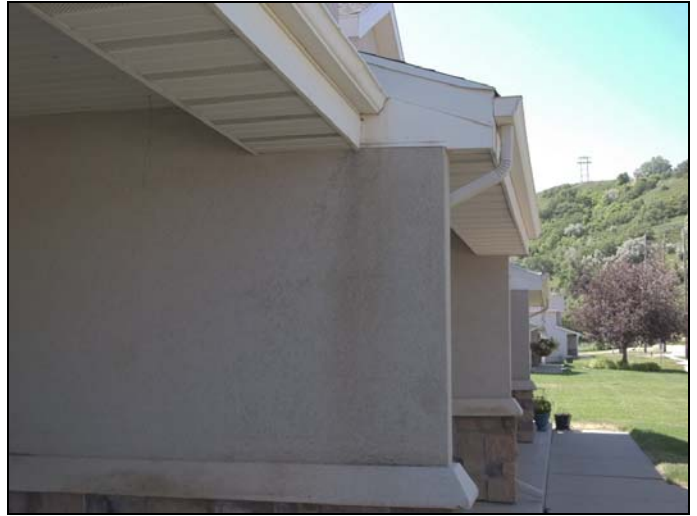
Comp #: 201 Stucco Surfaces - 2007-11 - Repair/Repaint

The stucco surfaces are in good condition. We recommend funding to repair/repaint this component approximately every 12 - 15 years to protect the stucco surface and maintain appearance. Remaining life based on current age.

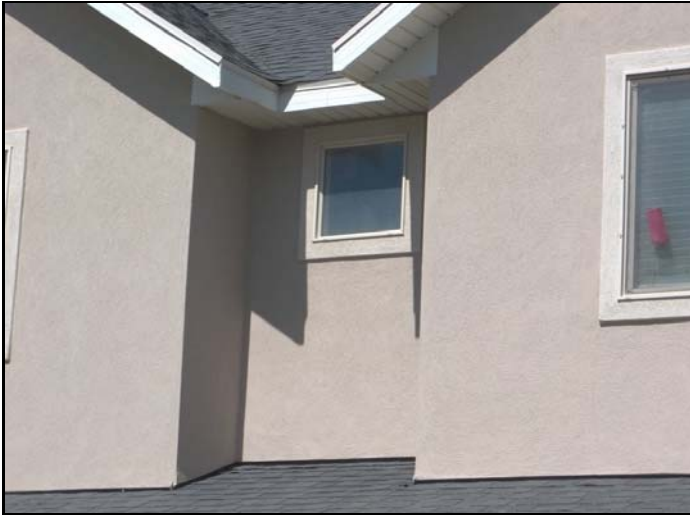
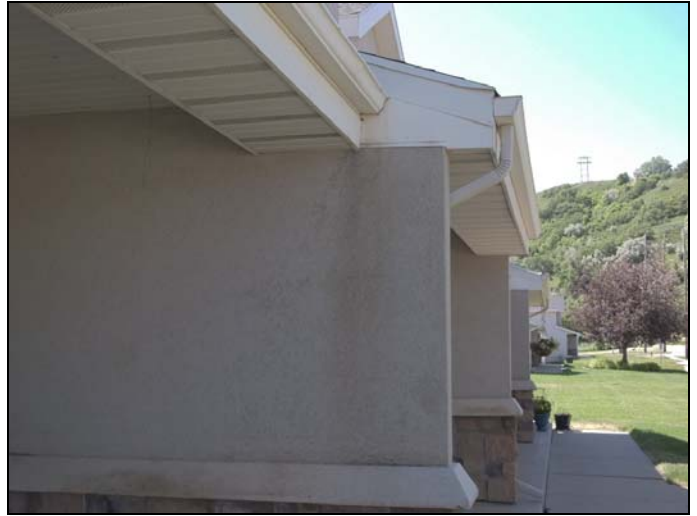
Comp #: 201 Stucco Surfaces - 2012-14 - Repair/Repaint

The stucco surfaces are in good condition. We recommend funding to repair/repaint this component approximately every 12 - 15 years to protect the stucco surface and maintain appearance. Remaining life based on current age.

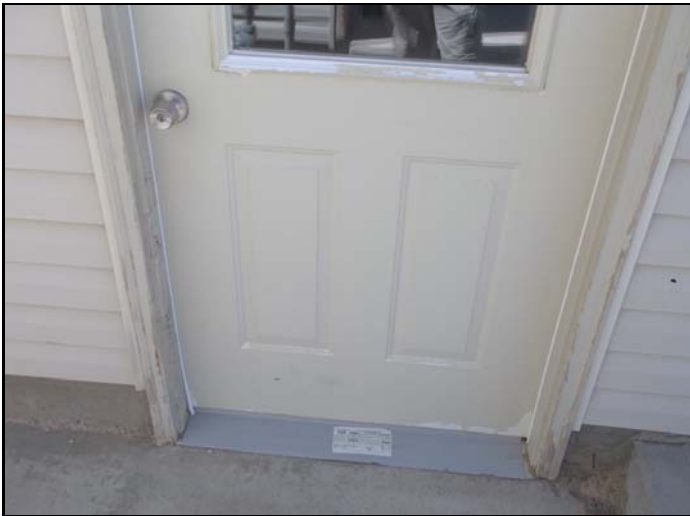
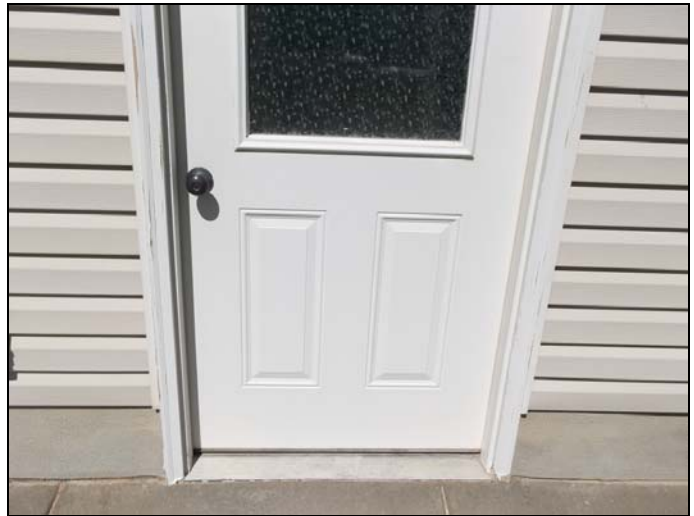
Comp #: 204 Doors - 2002-2011 - Repaint

The painted door surfaces are in fair to poor condition. We recommend funding to repaint this component approximately every 6 - 8 years to maintain appearance and protect surfaces. Remaining life based on age.

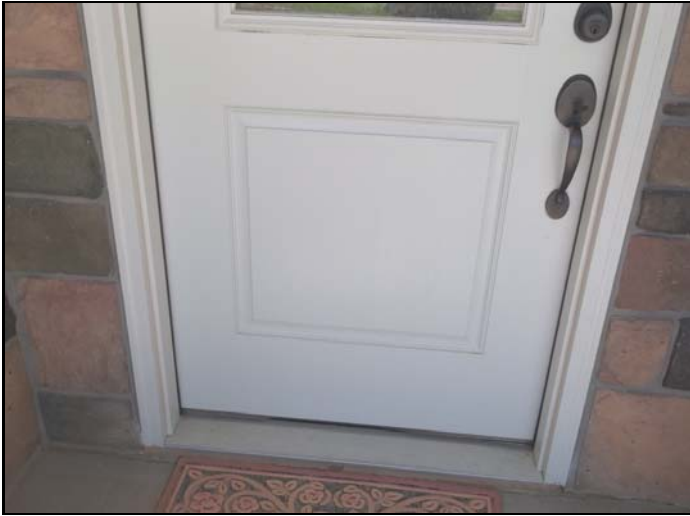
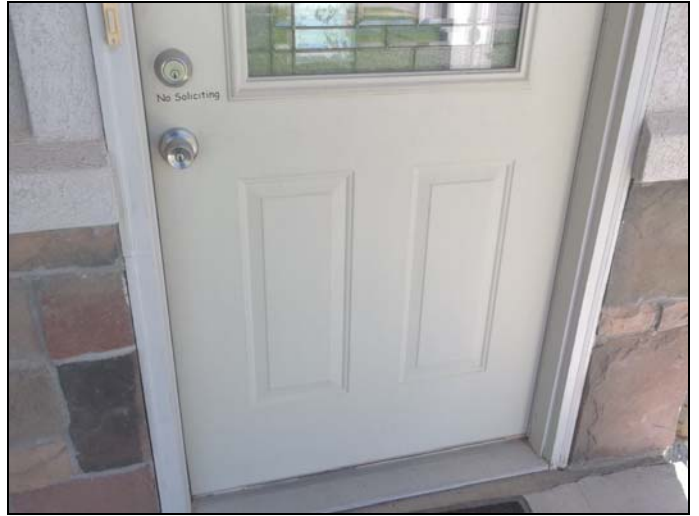
Comp #: 204 Doors - 2012-2014 - Repaint

The painted door surfaces are in good condition. We recommend funding to repaint this component approximately every 6 - 8 years to maintain appearance and protect surfaces. Remaining life based on age.

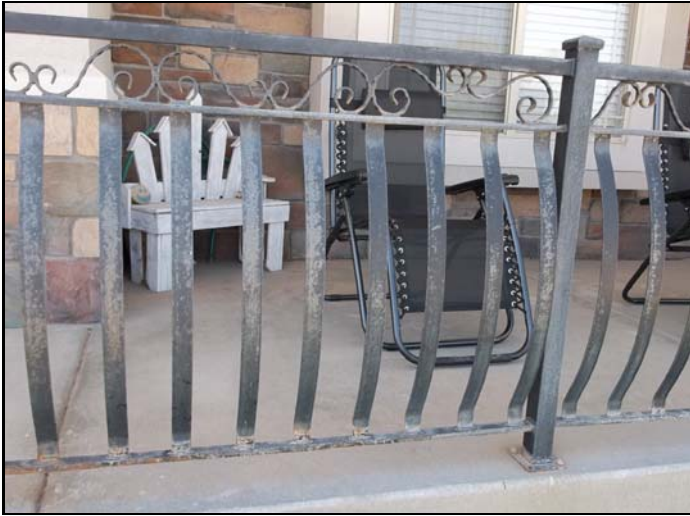
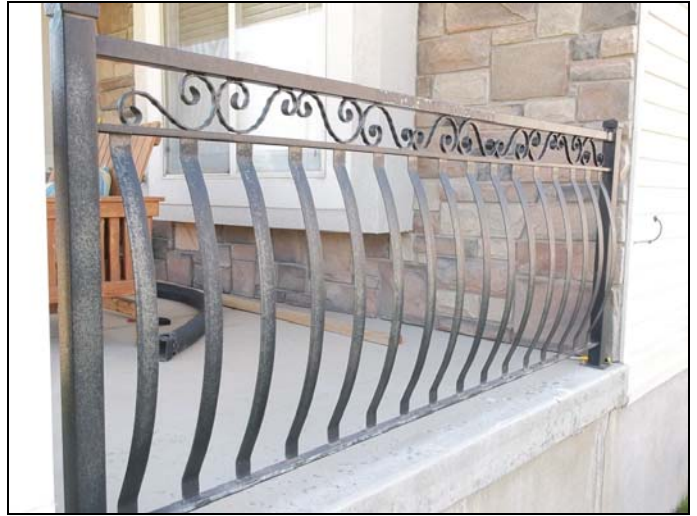
Comp #: 207 Metal Railing - Repaint

The painted metal fencing surfaces are in fair to poor condition. Fading and rust were noted at the time of the inspection. We recommend funding to repaint this component approximately every 6 years to maintain appearance and protect metal surfaces. Remaining life based on current condition.

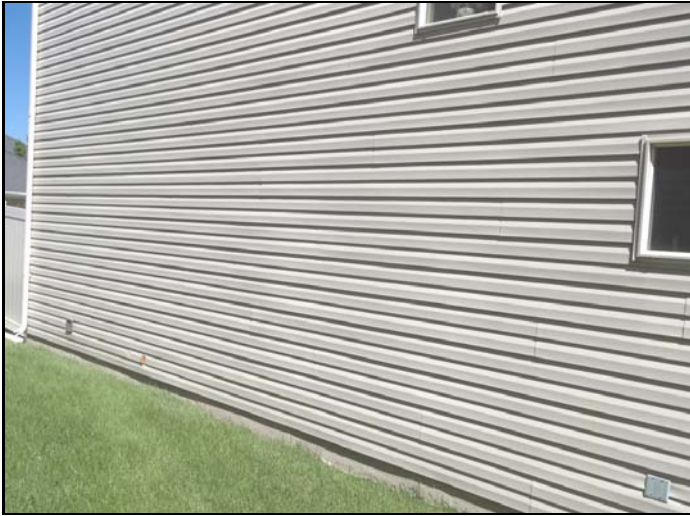
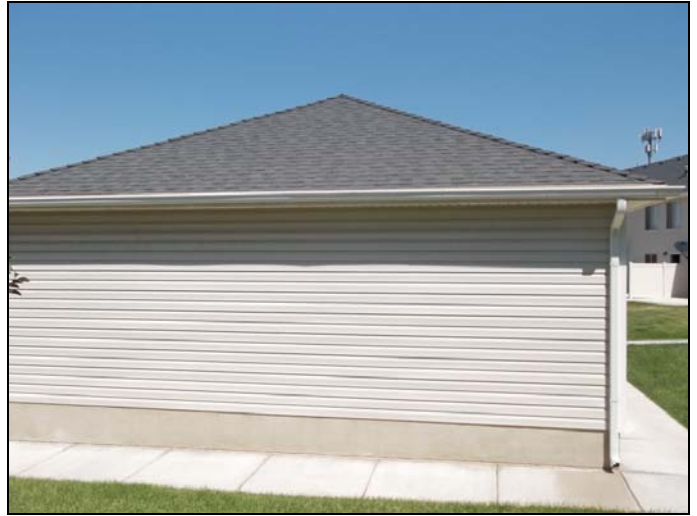
Comp #: 302 Vinyl Siding - 2002-06 - Replace

The vinyl siding is in good condition. Although this component may reach and extended useful life we recommend funding to replace this component approximately every 40 - 50 years to maintain appearance. Remaining life based on current age.

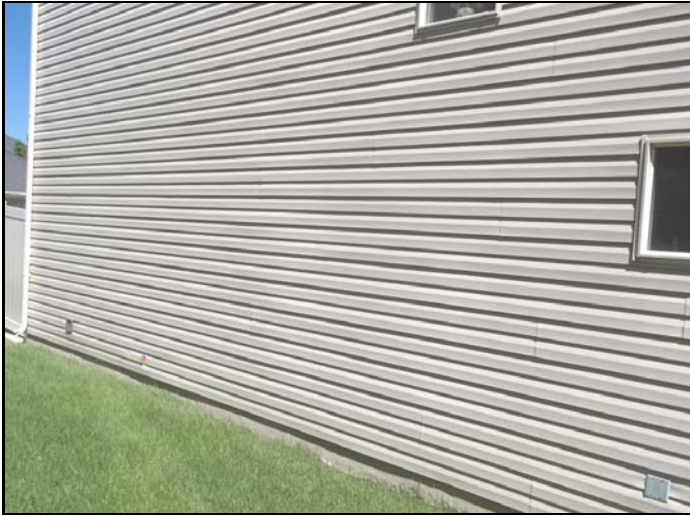
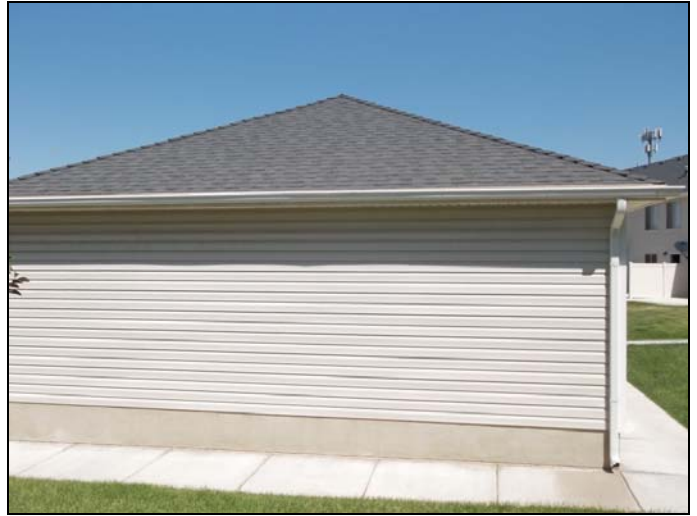
Comp #: 302 Vinyl Siding - 2007-11 - Replace

The vinyl siding is in good condition. Although this component may reach and extended useful life we recommend funding to replace this component approximately every 40 - 50 years to maintain appearance. Remaining life based on current age.

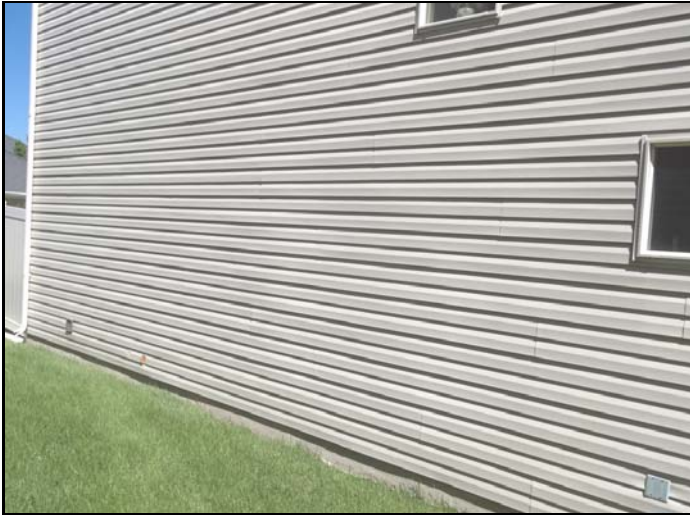
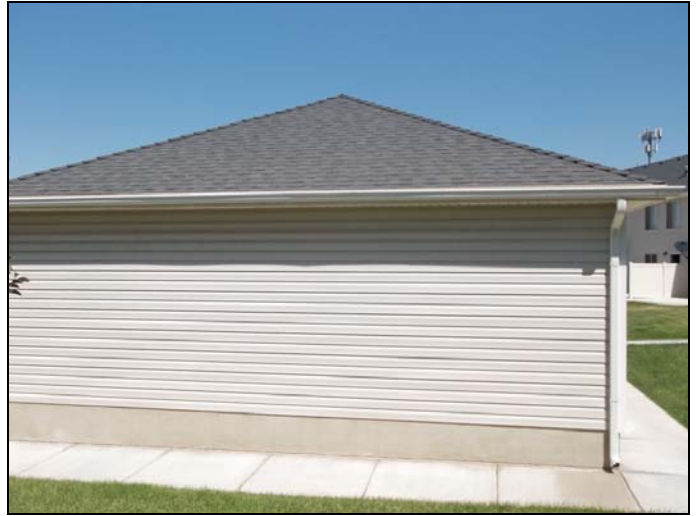
Comp #: 302 Vinyl Siding - 2012-14 - Replace

The vinyl siding is in good condition. Although this component may reach and extended useful life we recommend funding to replace this component approximately every 40 - 50 years to maintain appearance. Remaining life based on current age.

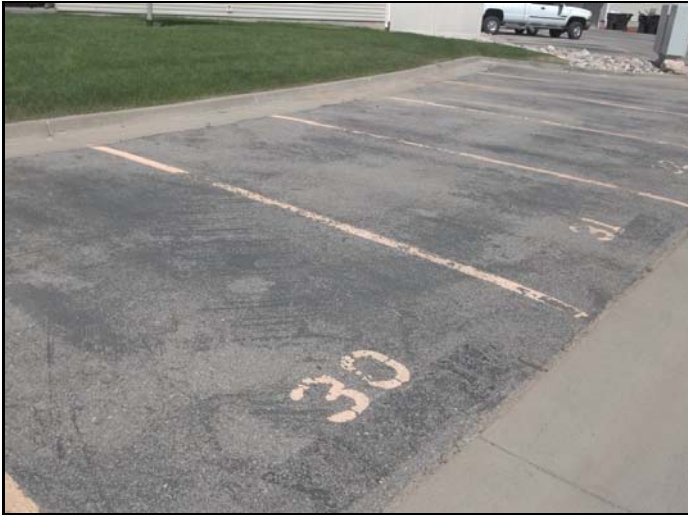
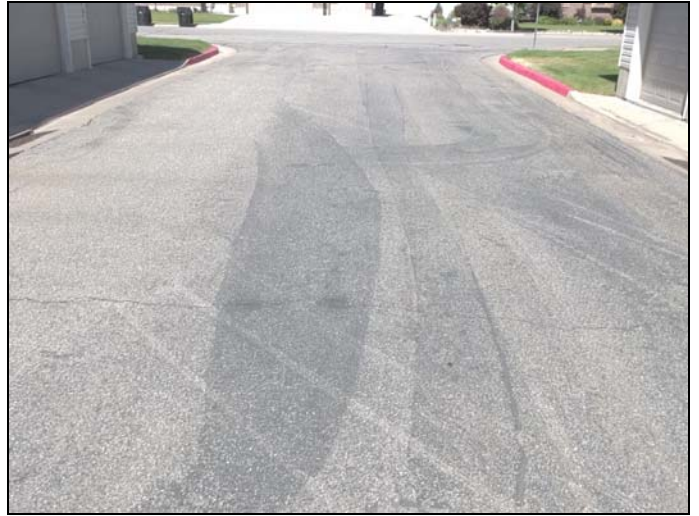
Comp #: 401 Asphalt - Overlay

The asphalt streets are in good condition. Cracking and raveling were noted at the time of the inspection. Asphalt overlay generally has a useful life of 20 - 25 years. Maintain seal coat schedule to ensure full useful life (see Comp# 402 Asphalt - Seal Coat). Remaining life based on current age.

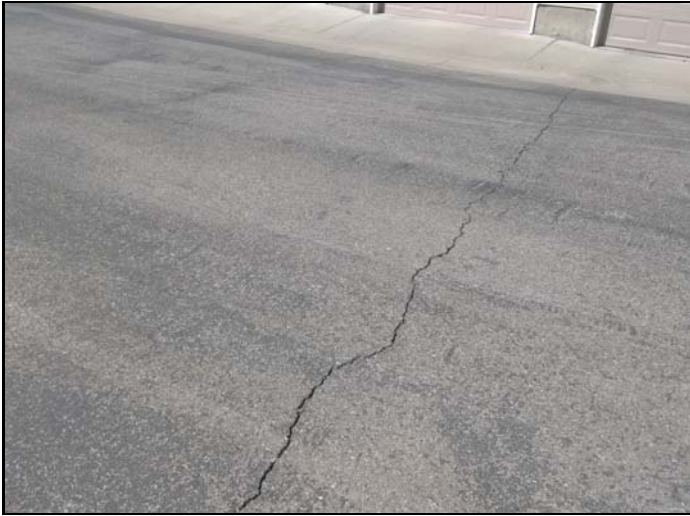
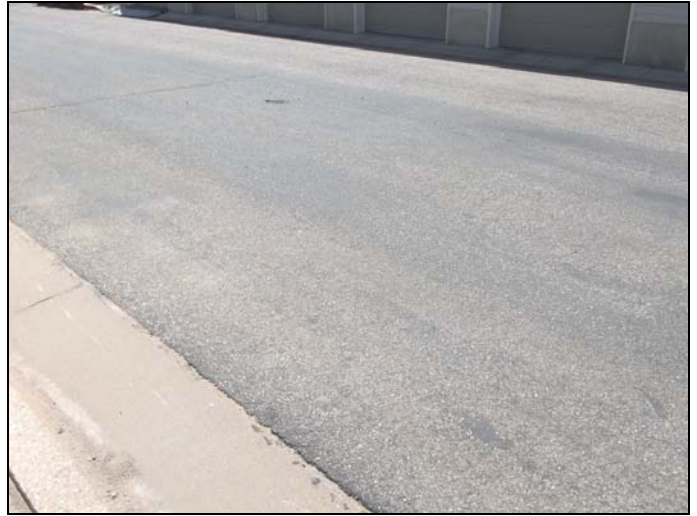
Comp #: 402 Asphalt - Seal Coat & Crack Seal

Research with the client reveals this component is being sealed in 2017. Seal asphalt surfaces regularly to prevent premature overlay (see Comp# 401 Asphalt - Overlay). We recommend funding to seal this component approximately every 3 - 5 years. Remaining life based on current age.

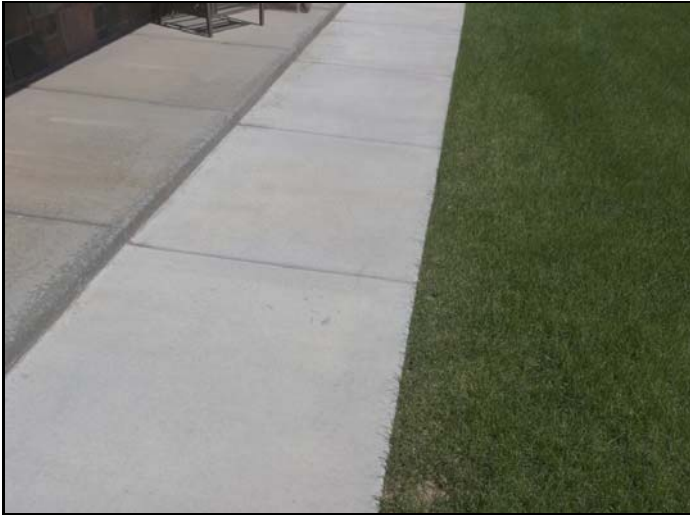
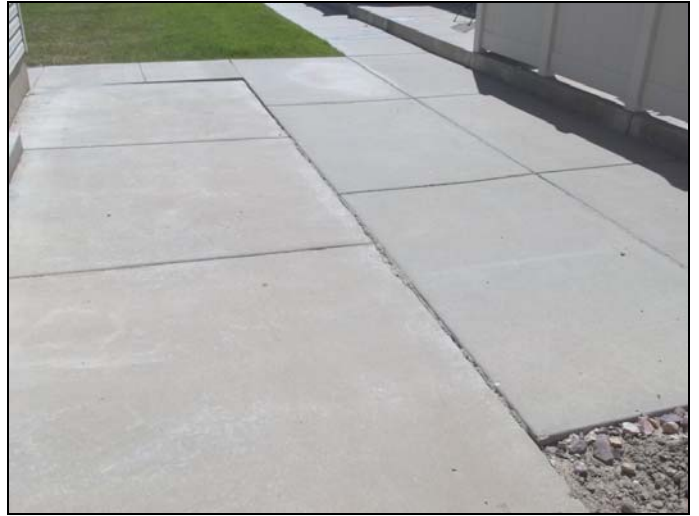
Comp #: 403 Concrete - Repair/Replace

The concrete is generally in good condition. Areas of cracking, spalling, and settling were noted at the time of the inspection. No expectation to completely replace the concrete surfaces. We recommend making local repairs as necessary as an operating expense and funding to make more significant repairs approximately every 10 years. Remaining life based on current age.

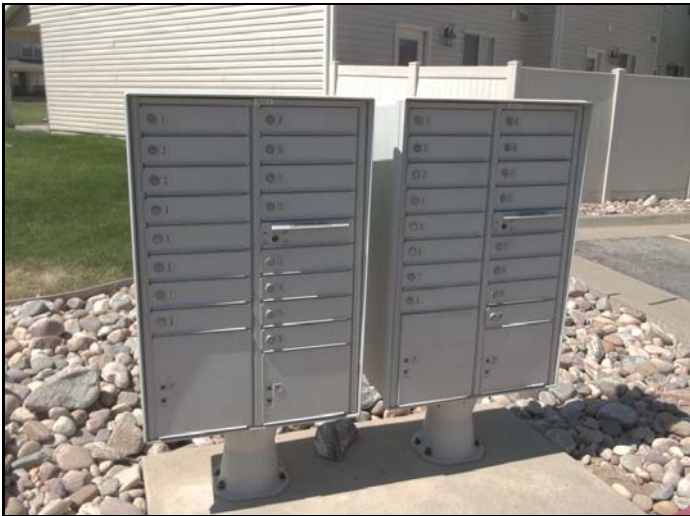
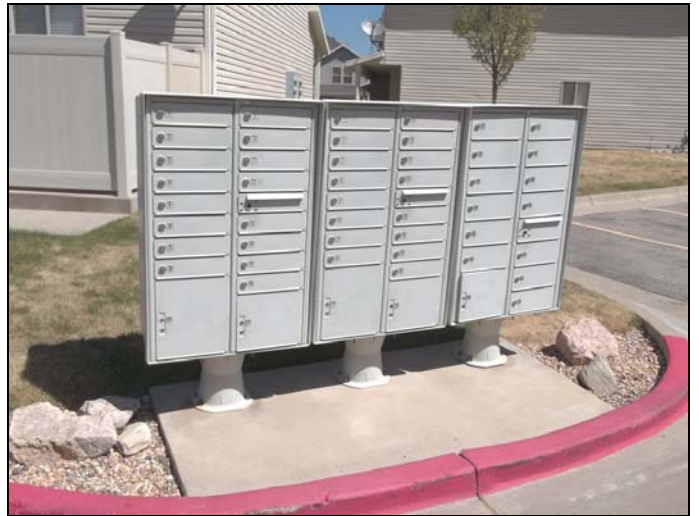
Comp #: 803 Mailboxes - Replace

The mailboxes are in good condition. Typically these mailboxes are owned and maintained by the postal service. No reserve funding necessary.

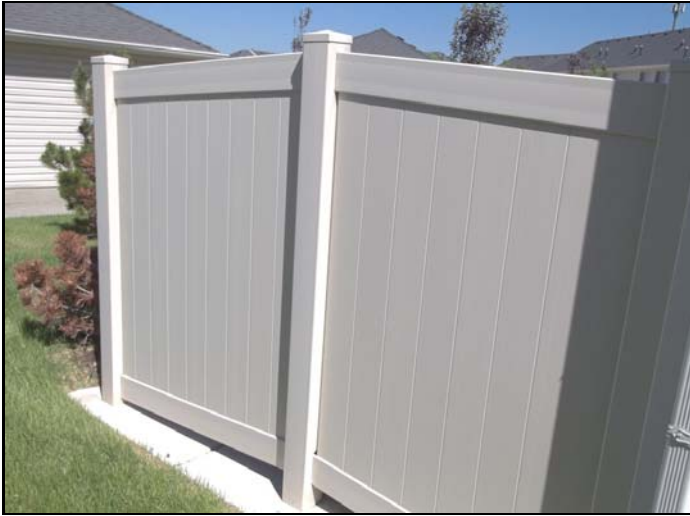
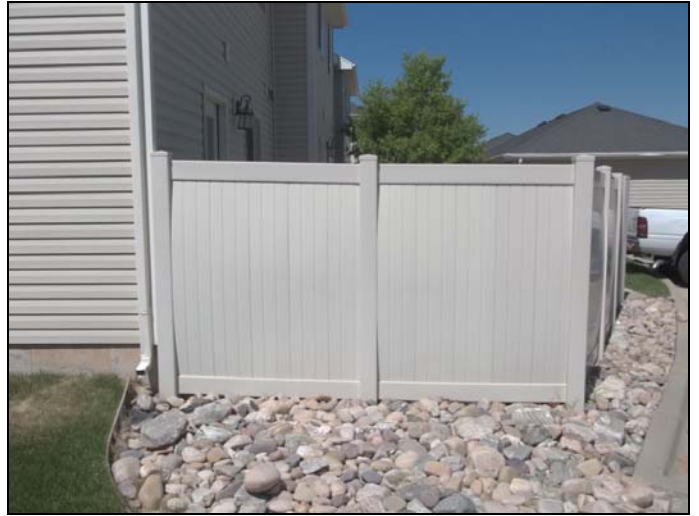
Comp #: 1008 Vinyl Fencing - Replace

The vinyl fencing is in good condition. We recommend funding to replace this component approximately every 25 - 30 years. Remaining life based on current average age.

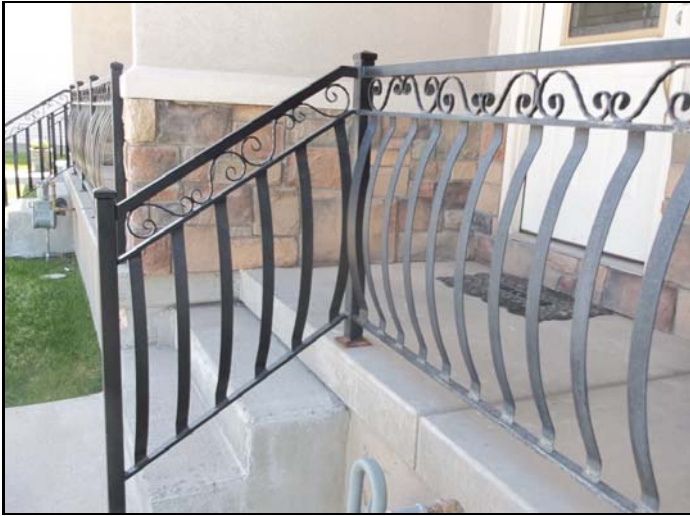
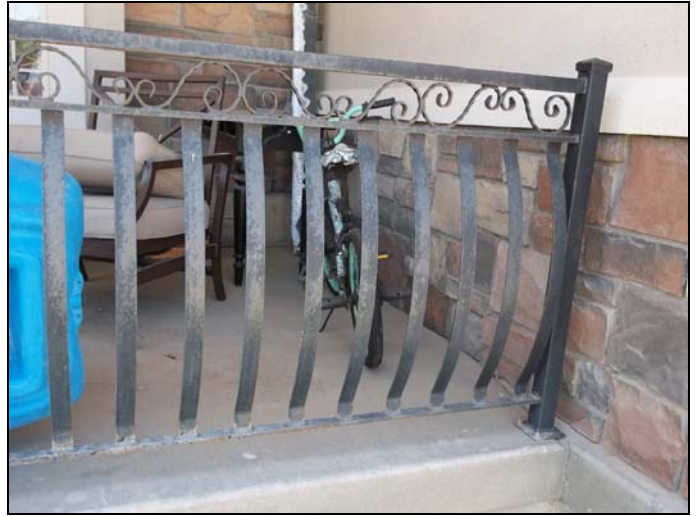
Comp #: 1090 Metal Railing - Replace

The metal railing is in good condition. Areas of rust were noted at the time of inspection. We recommend funding to replace this component approximately every 30 - 40 years. Remaining life based on current age.

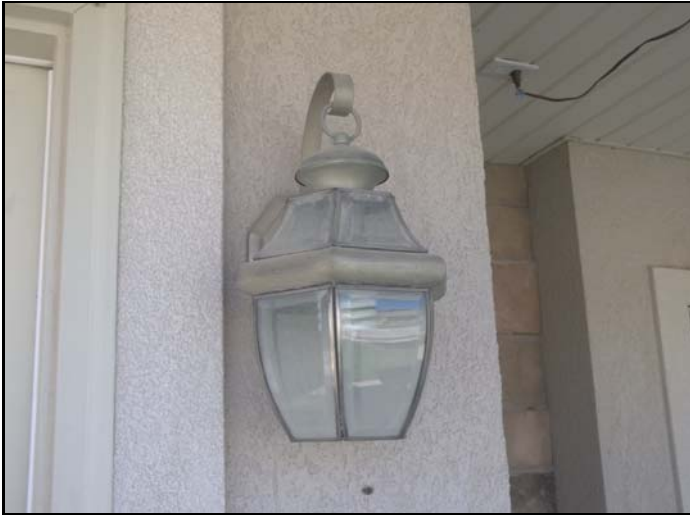
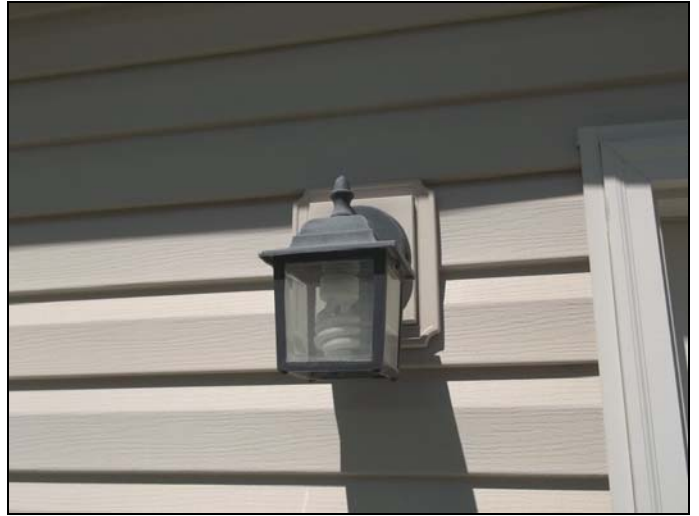
Comp #: 1602 Exterior Light Fixtures - 2002-06 - Replace

The exterior light fixtures are in good to fair condition. We recommend funding to replace this component approximately every 16 - 20 years to maintain appearance and function. Remaining life based on current age.

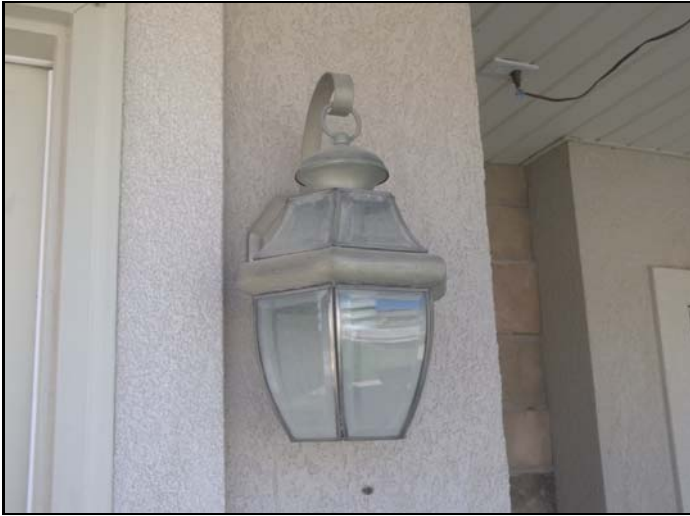
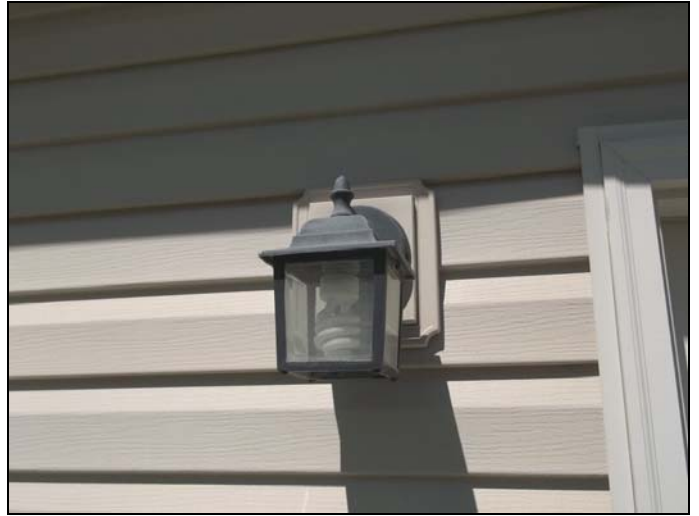
Comp #: 1602 Exterior Light Fixtures - 2007-11 - Replace

The exterior light fixtures are in good condition. We recommend funding to replace this component approximately every 16 years to maintain appearance and function. Remaining life based on current age.

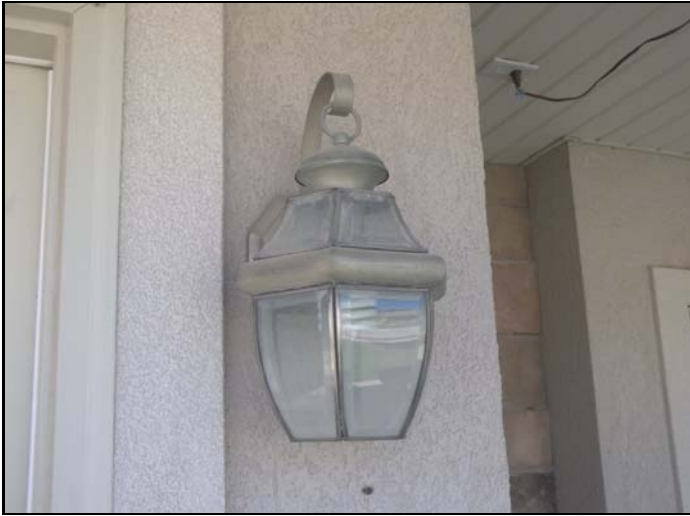
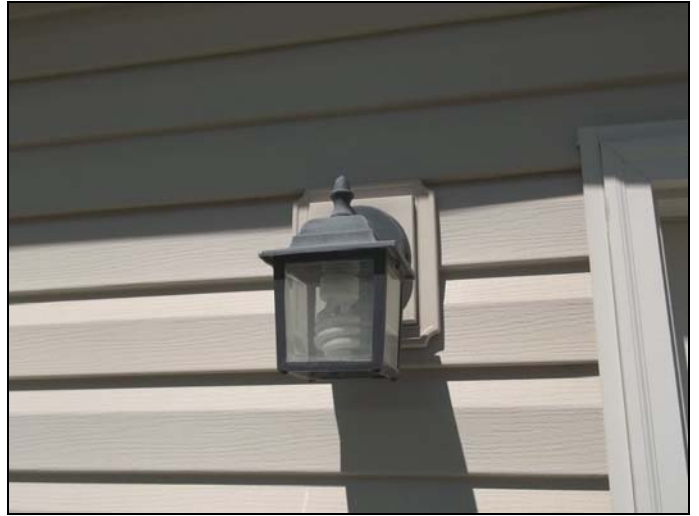
Comp #: 1602 Exterior Light Fixtures - 2012-14 - Replace

The exterior light fixtures are in good condition. We recommend funding to replace this component approximately every 16 years to maintain appearance and function. Remaining life based on current age.

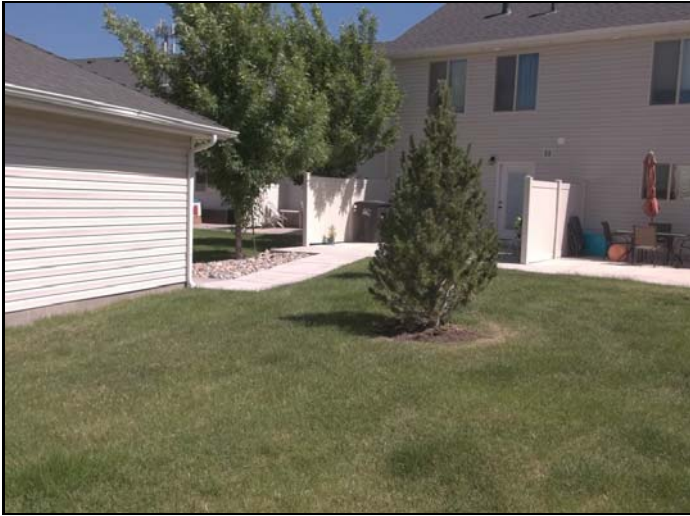
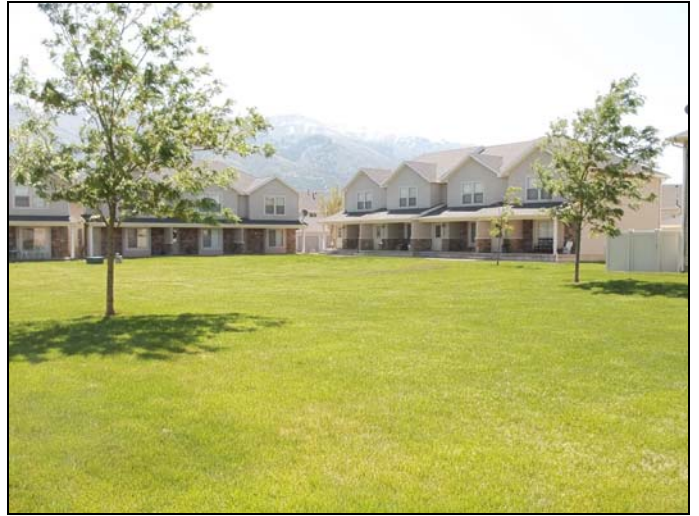
Comp #: 1812 Landscaping & Irrigation System - Renovate

The landscaping and irrigation system are in working condition. We recommend funding for an allowance to renovate the landscaping and irrigation system approximately every 20 years. Remaining life based on current age.
