# Antelope Village

## Level 2 Reserve Study

Report Period – 01/01/2019 – 12/31/2019

Type of Study	Update w/Site Visit
Date of Property Inspection	8/27/2018
Prepared By	Dale Gifford
Analysis Method	Cash Flow
Funding Goal	Full Funding

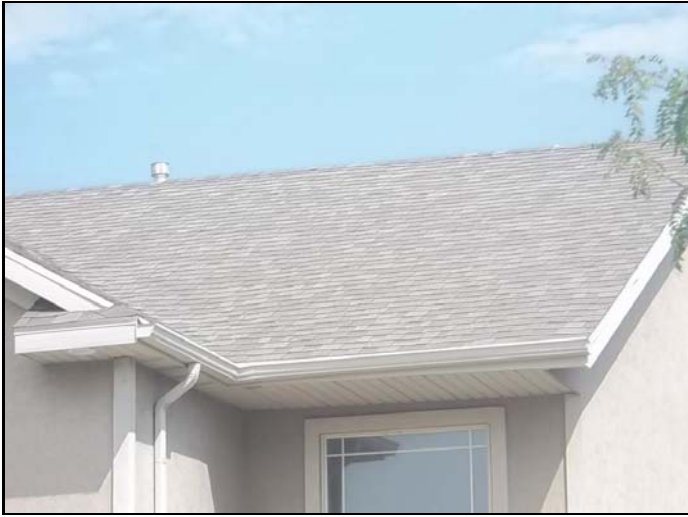
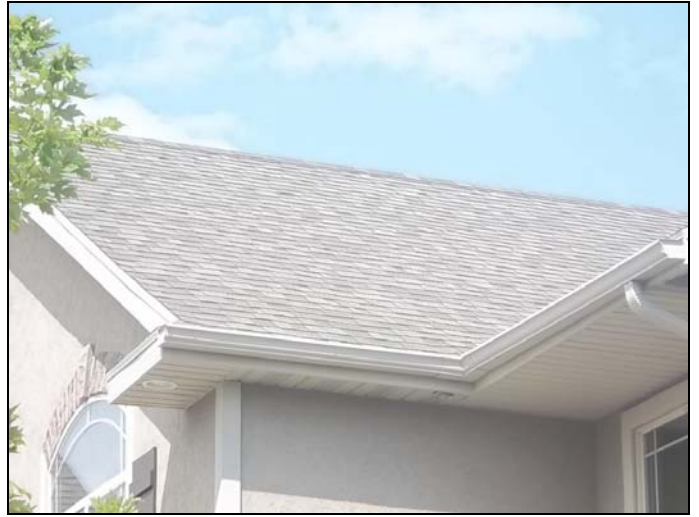
Comp #: 105 Roofs - Replace

*Location:* **Building Roofs**

The roofs are in good condition. We recommend funding to replace this component approximately every 20 - 25 years. Remaining life based on current age.

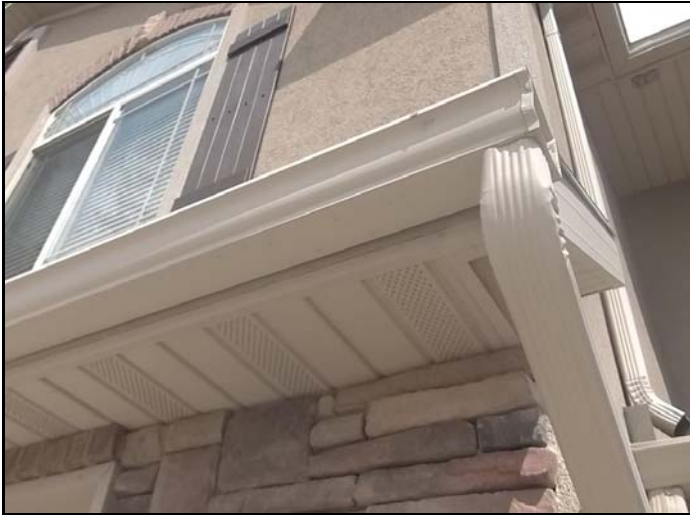
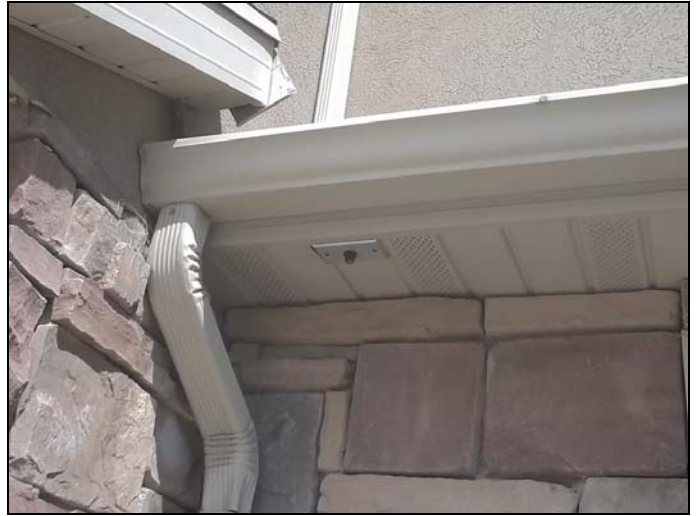
Comp #: 120 Rain Gutters/Downspouts - Replace

*Location:* **Building Roofs**

The rain gutters and downspouts are in good condition. We recommend funding to replace this component approximately every 25 - 30 years. Remaining life based on current age.

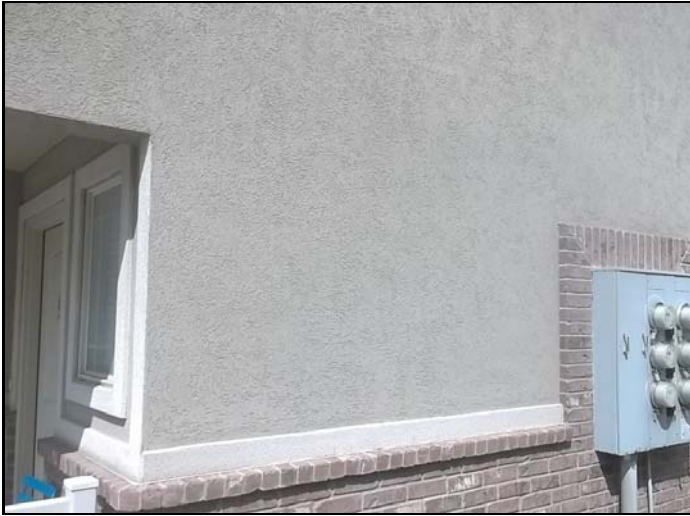
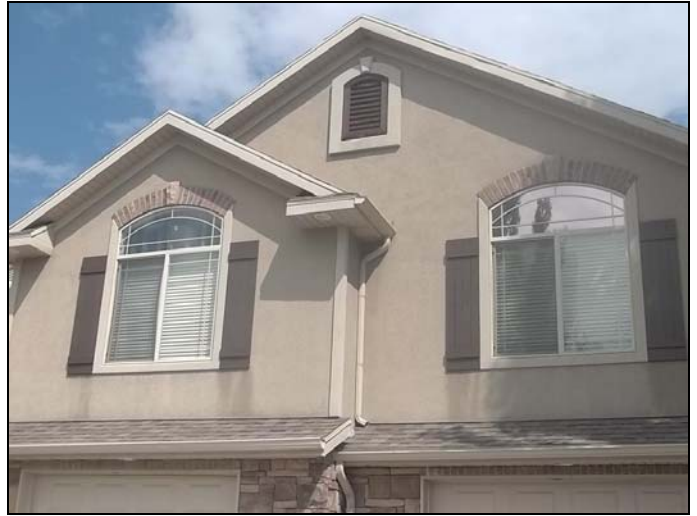
Comp #: 201 Stucco Surfaces - Repair/Repaint

*Location:* **Building Exteriors**

The stucco surfaces are in good to fair condition. We recommend funding to repair/repaint this component approximately every 12 - 15 years. Remaining life based on current age.

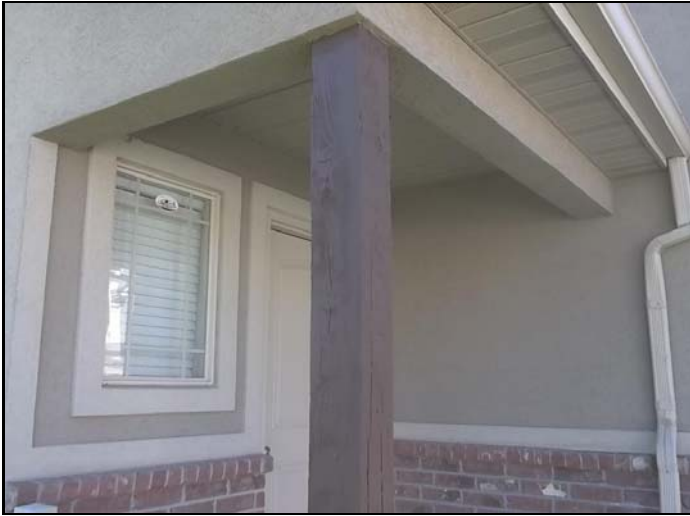
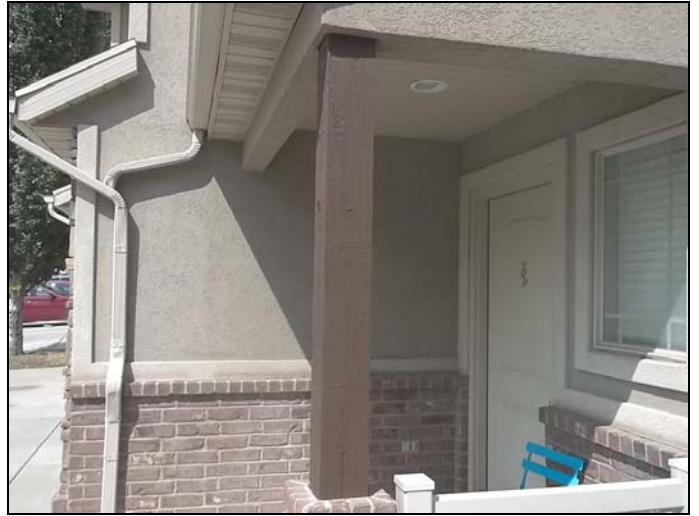
Comp #: 202 Porch Poles - Repaint

*Location:* **Building Exteriors**

The painted surfaces are in good condition. We recommend funding to repaint this component approximately every 3 - 5 years. Remaining life based on current age.

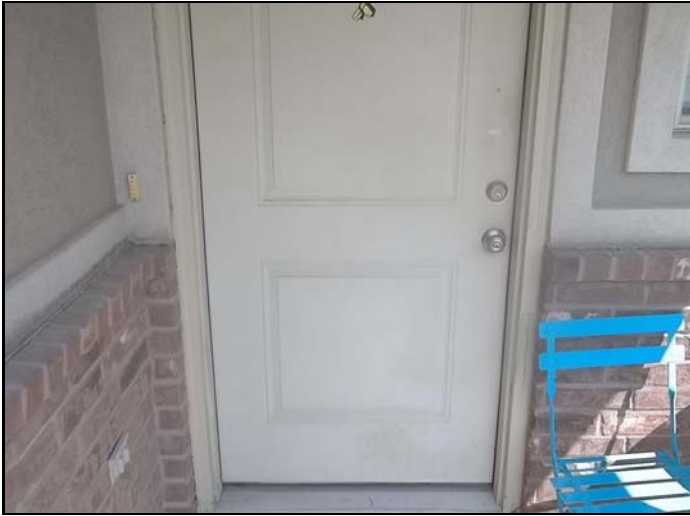
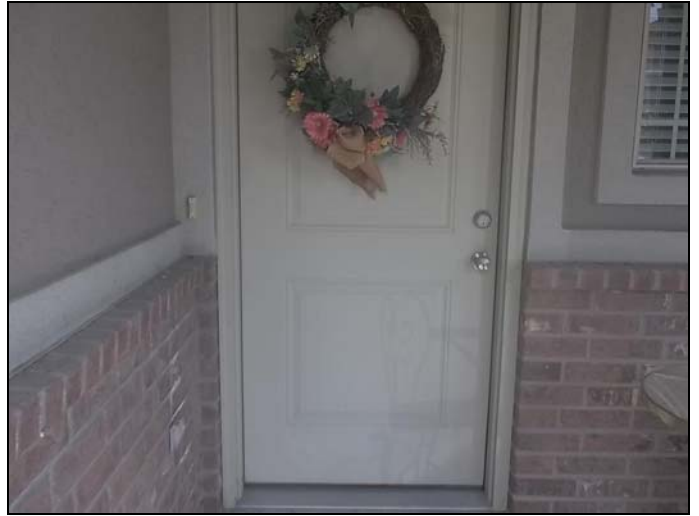
Comp #: 204 Front Doors - Repaint

*Location:* **Unit Front Doors**

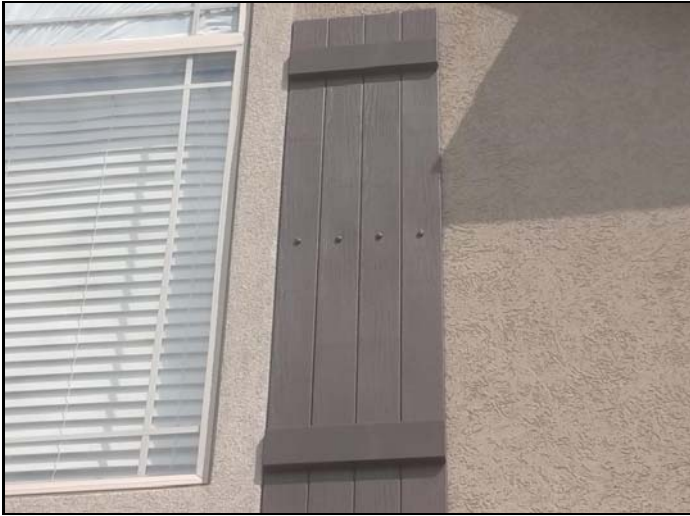
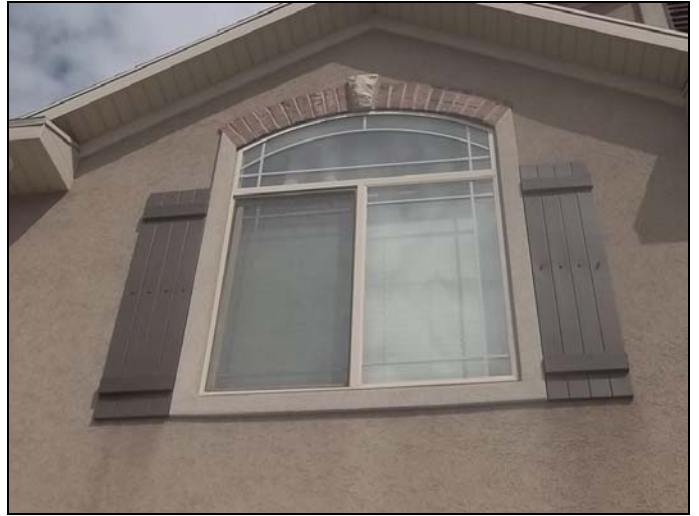
Comp #: 219 Faux Shutters - Repaint

*Location:* **Building Exteriors**

The painted surfaces are in good condition. We recommend funding to repaint this component approximately every 6 years. Remaining life based on current age.

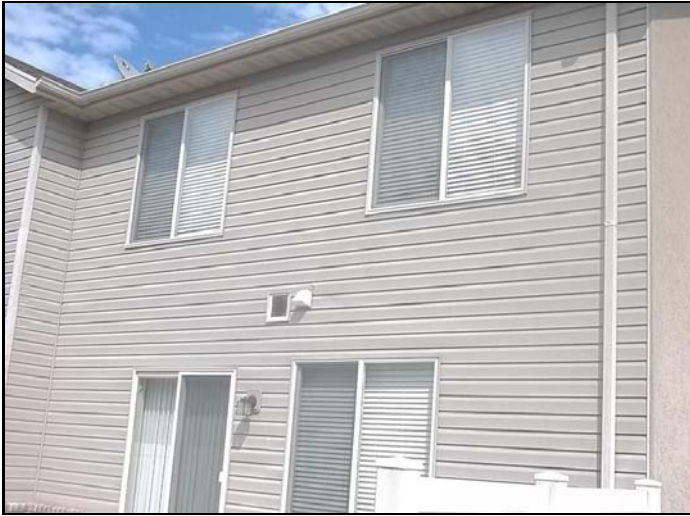
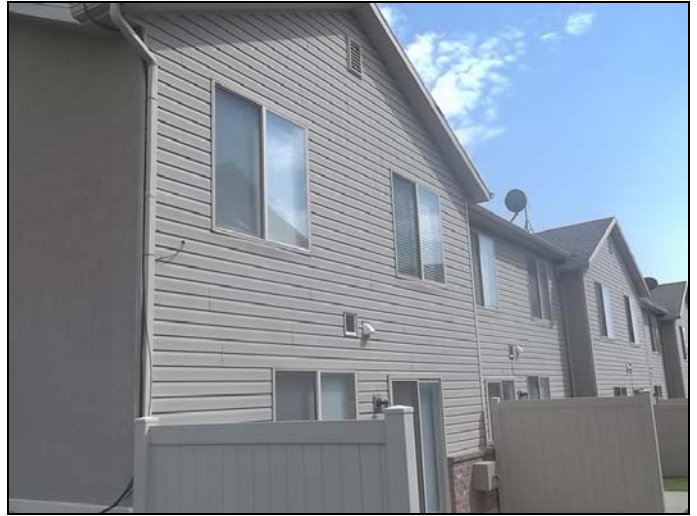
Comp #: 302 Vinyl Siding - Replace

*Location:* **Building Exteriors**

The vinyl siding is in good condition. We recommend funding to replace this component approximately every 40 - 50 years. Remaining life based on current age.

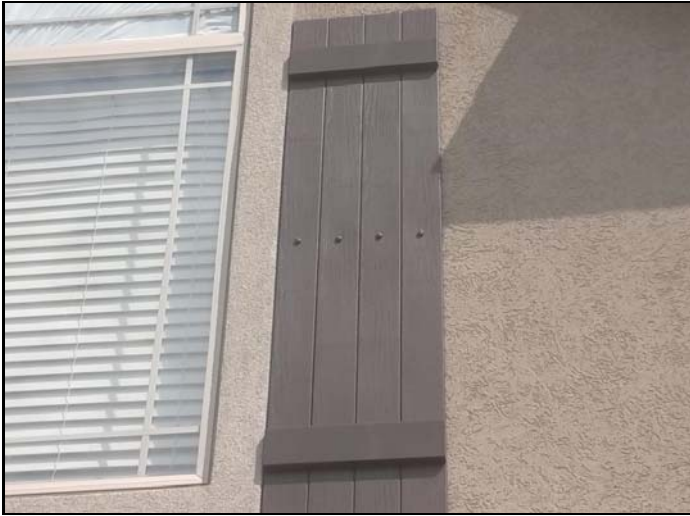
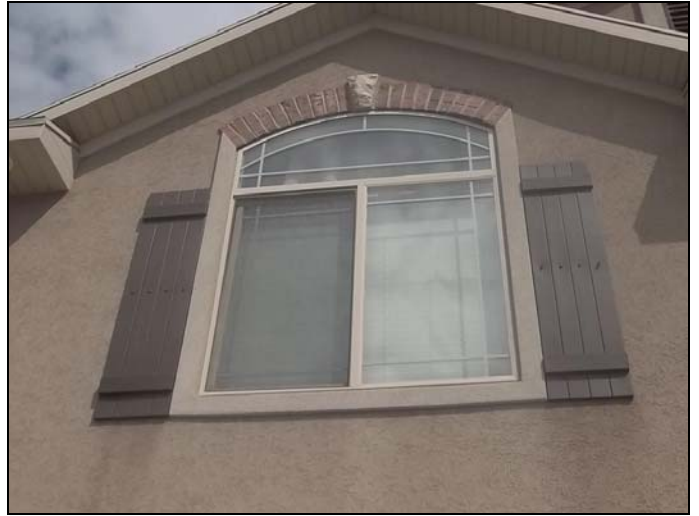
Comp #: 390 Faux Shutters - Replace

*Location:* **Building Exteriors**

The shutters are in good condition. We recommend funding to replace this component approximately every 20 - 30 years. Remaining life based on current age.

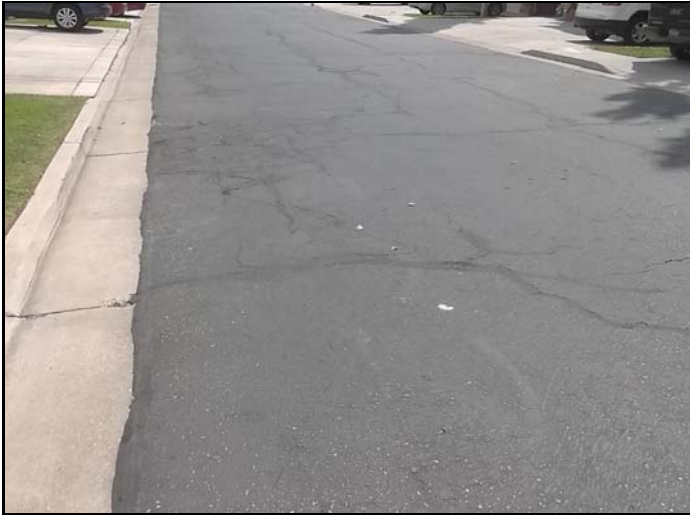
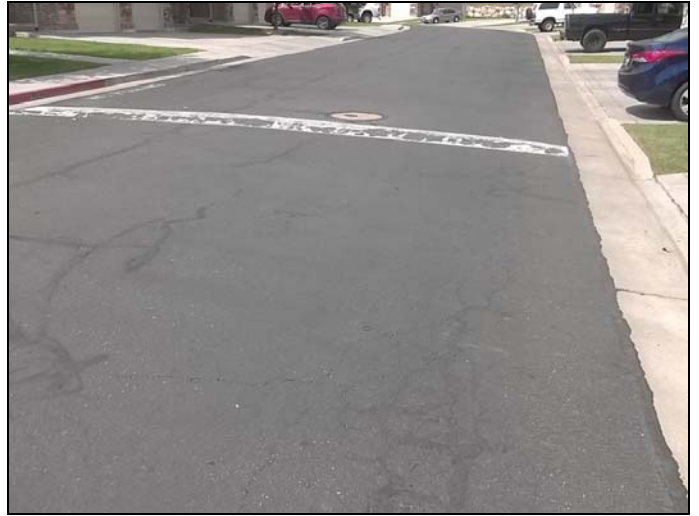
Comp #: 401 Asphalt - Major Rehab

*Location:* **Community Parking Areas & Streets**

The asphalt surfaces are in good to fair condition. We recommend funding for a major rehab of this component approximately every 20 - 25 years. Remaining life based on current age.

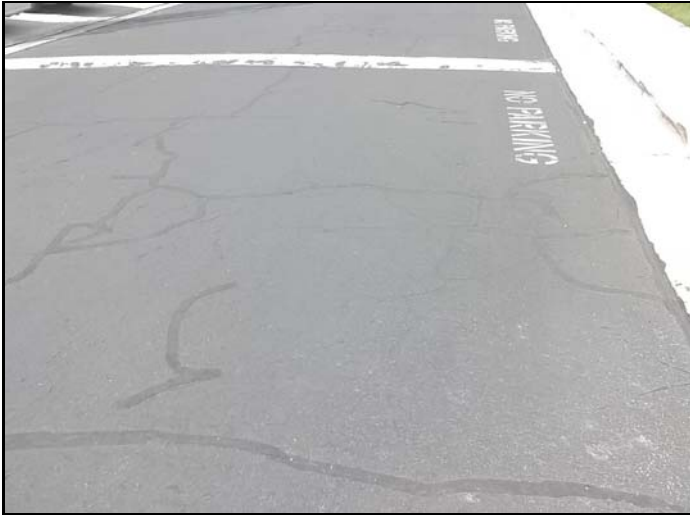
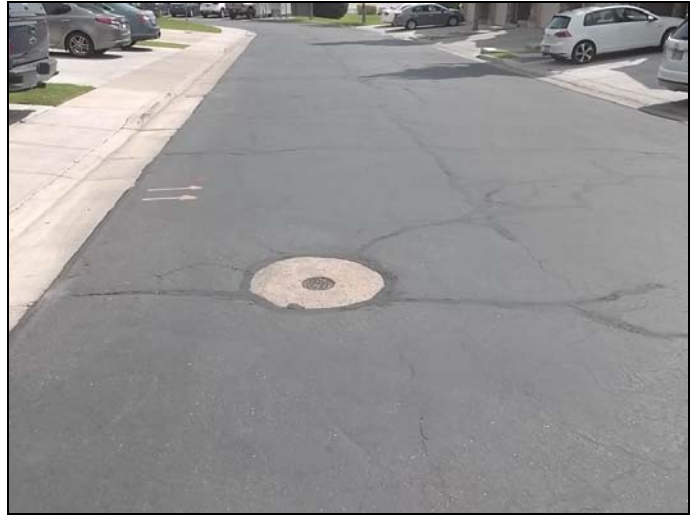
Comp #: 402 Asphalt - Seal Coat

*Location:* **Community Parking Areas & Streets**

The asphalt seal coat is in fair to poor condition. We recommend funding to seal this component approximately every 3 - 5 years. Remaining life based on current condition.

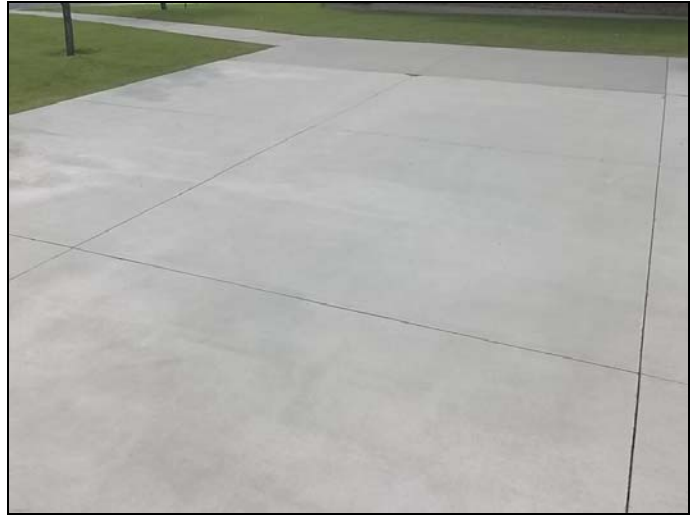
Comp #: 403 Concrete - Repair/Replace

*Location:* **Community Driveways & Sidewalks**

The concrete is in good condition. This component has an extended useful life under normal conditions. We recommend funding to make repairs and partially replace this component approximately every 10 years. Remaining life based on current age.

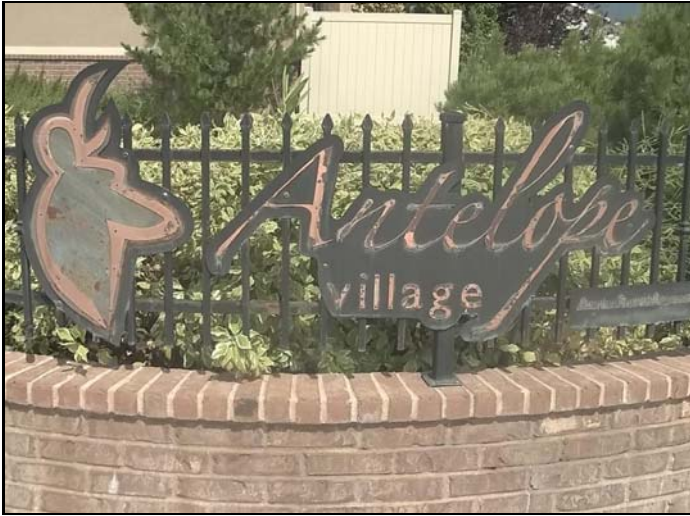
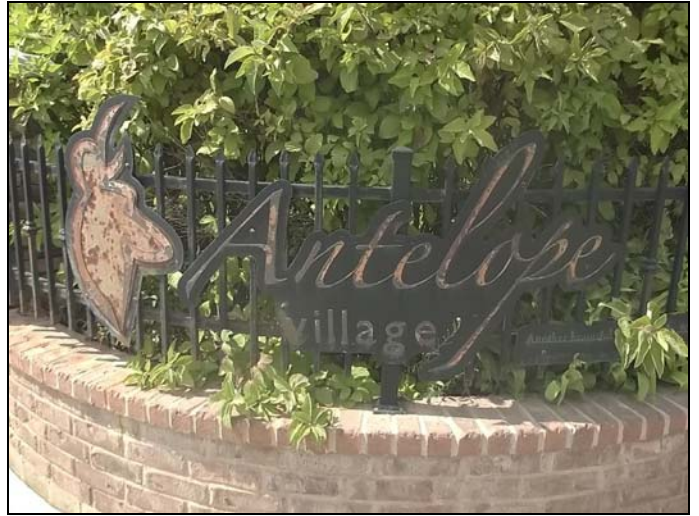
Comp #: 801 Community Signs - Replace

*Location:* **Community Entrance**

The community signs are in fair condition. We recommend funding to replace this component approximately every 18 - 20 years. Remaining life is based on current age.

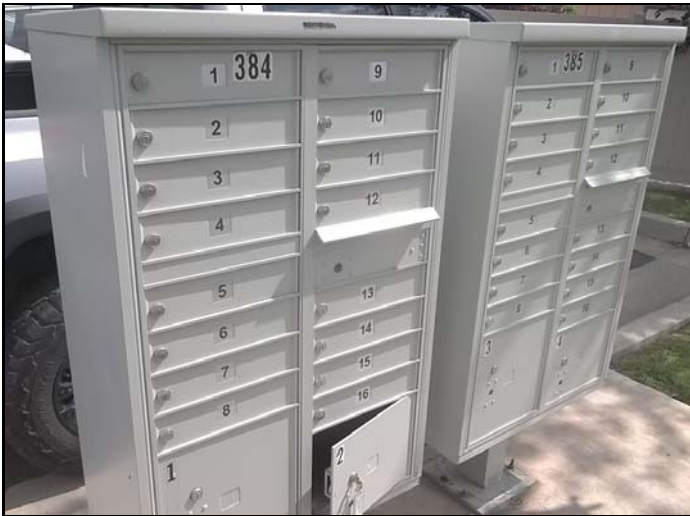
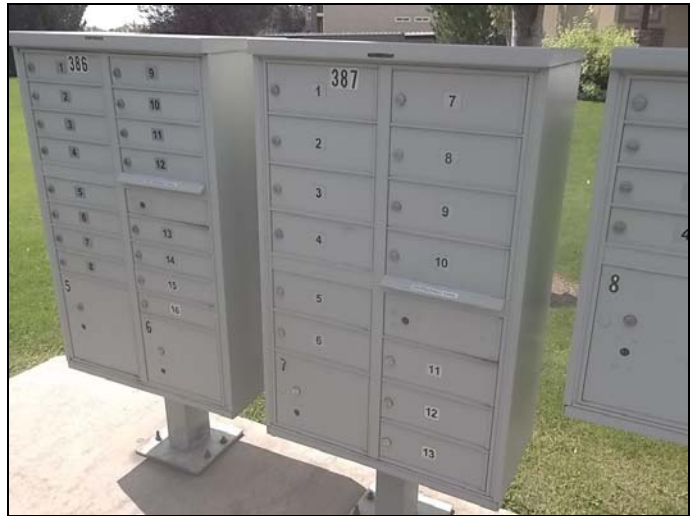
Comp #: 803 Mailboxes - Replace

*Location:* **Common Area**

The mailboxes are in good condition. We recommend funding to replace this component approximately every 18 - 20 years. Remaining life based on current age.

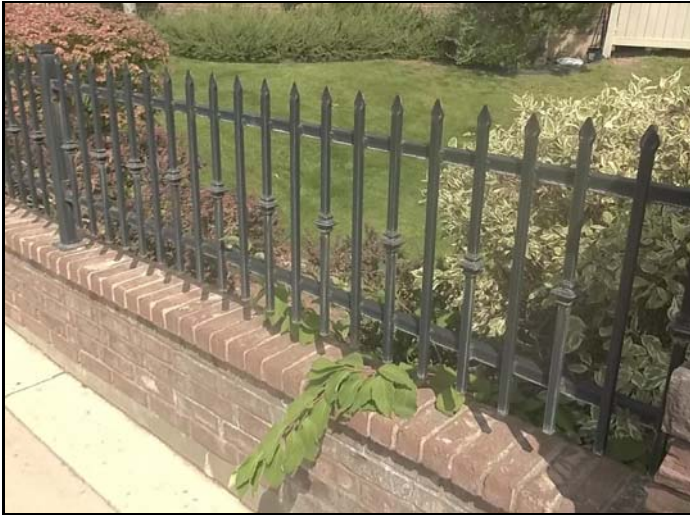
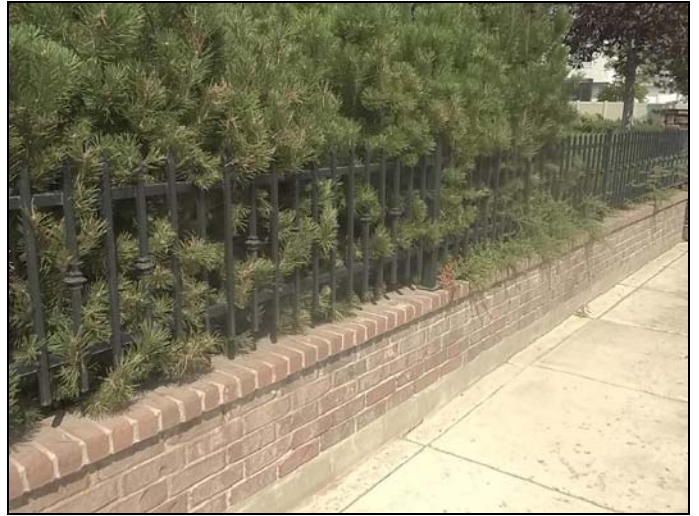
Comp #: 1002 Metal Fencing - Replace

*Location:* **Community South Perimeter**

The metal fencing is in good condition. We recommend funding to replace this component approximately every 40 - 50 years. Remaining life based on current age.

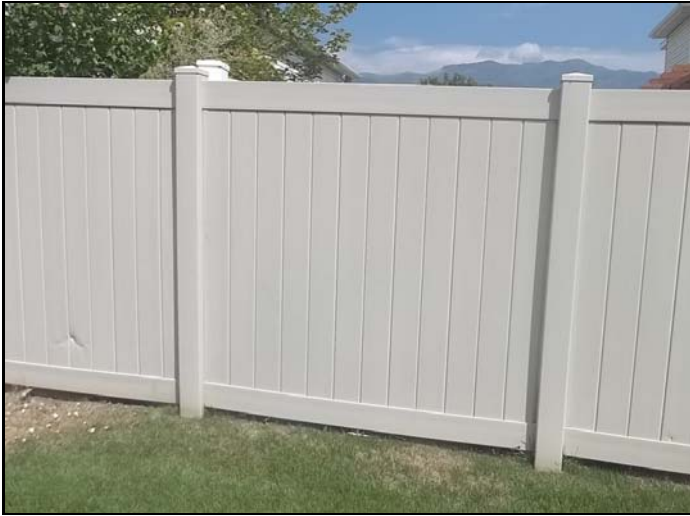
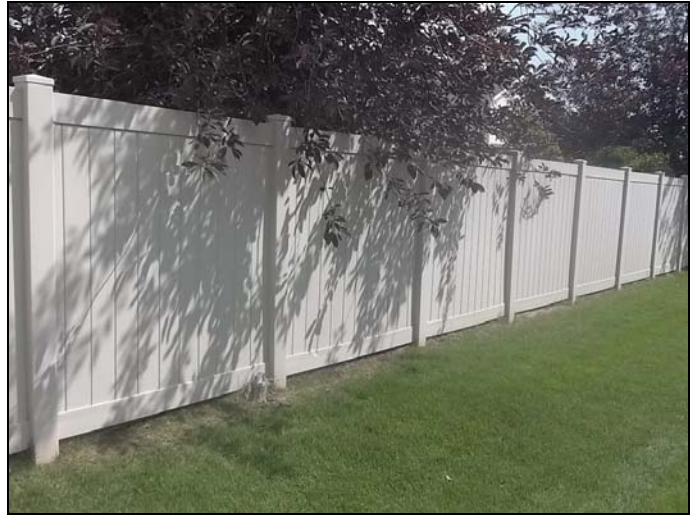
Comp #: 1008 Vinyl Fencing & Railing - Replace

*Location:* **Backyard Dividers & East Perimeter**

The vinyl fencing is in good to fair condition. We recommend funding to replace this component approximately every 25 - 30 years. Remaining life based on current age.

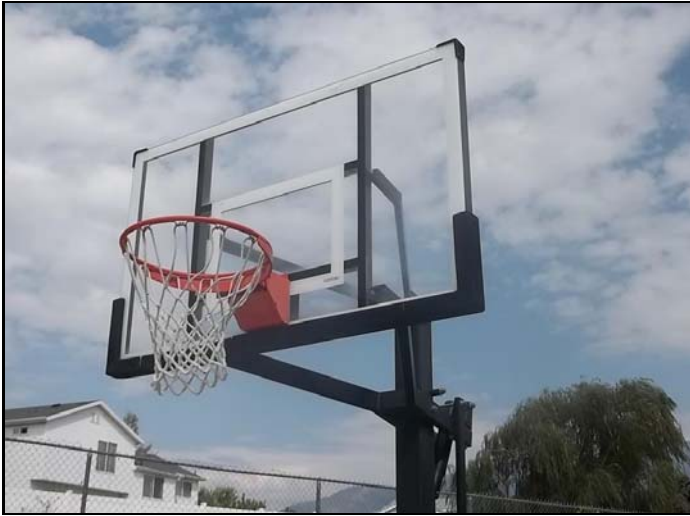
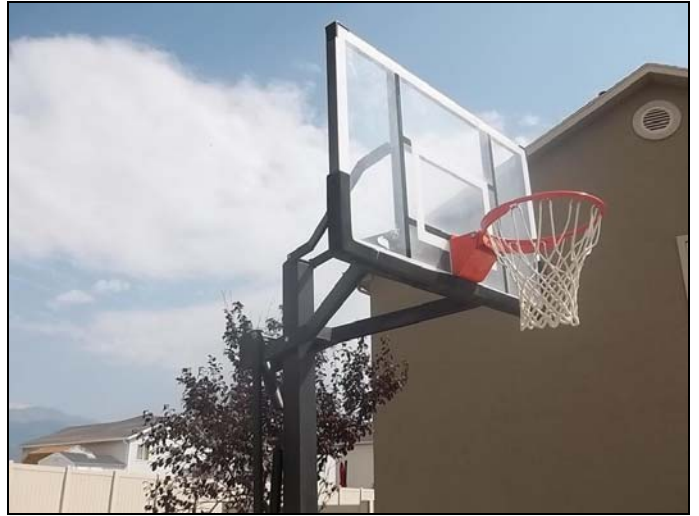
Comp #: 1207 Basketball Equipment - Replace

*Location:* **Common Area**

The basketball equipment is in good to fair condition. We recommend funding to replace this component approximately every 10 - 12 years. Remaining life is based on current condition.

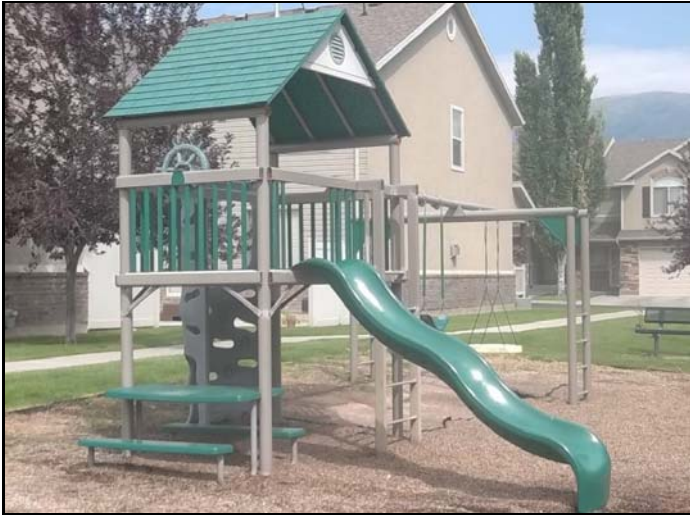
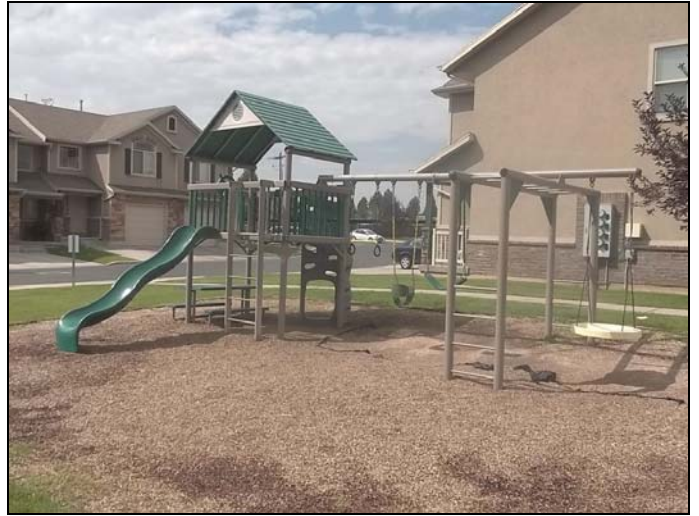
Comp #: 1301 Play Structure - Replace

*Location:* **Common Area**

The play structure is in fair condition. We recommend funding to replace this component approximately every 15 - 20 years. Remaining life based on current age.

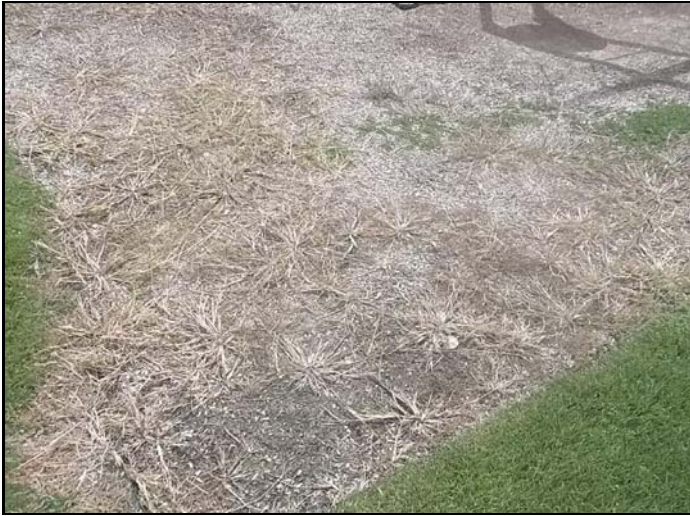
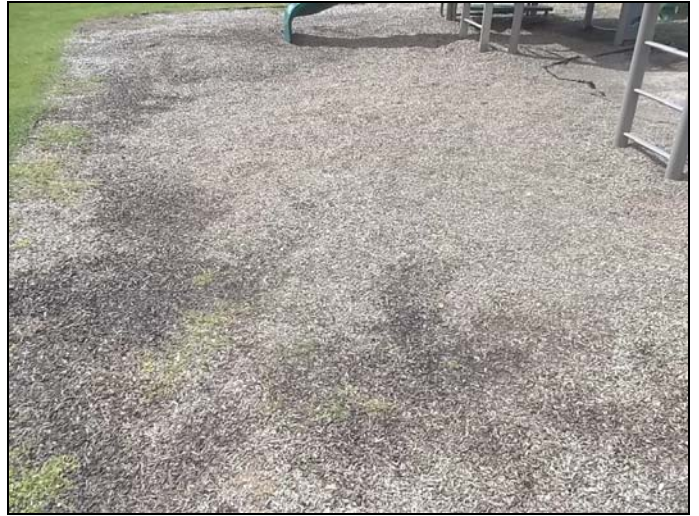
Comp #: 1303 Play Area Groundcover - Refill

*Location:* **Play Area**

The play area groundcover is in poor condition. We recommend funding to refill this component approximately every 3 - 5 years. Remaining life is based on current condition.

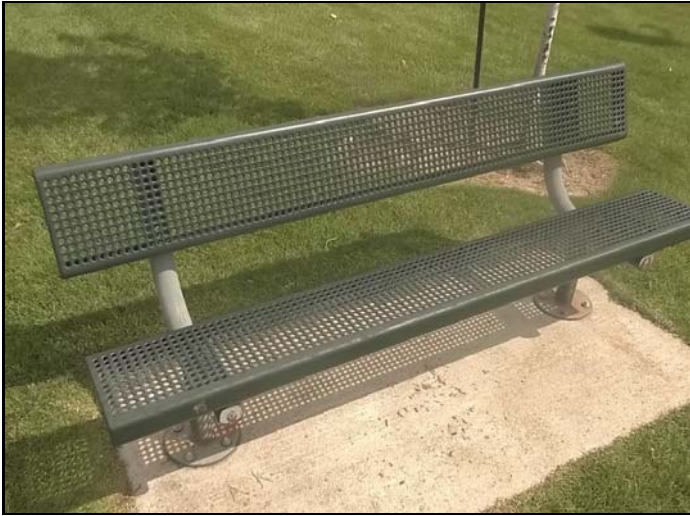
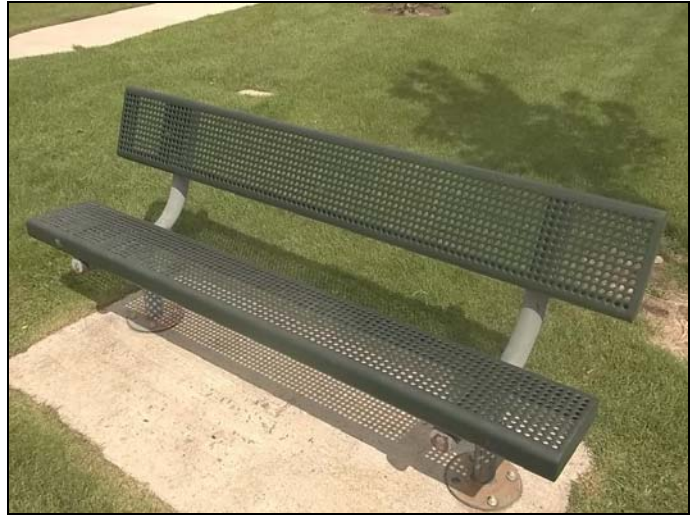
Comp #: 1307 Bench - Replace

*Location:* **Play Area**

The bench is in fair condition. We recommend funding to replace this component approximately every 10 - 15 years. Remaining life based on current age.

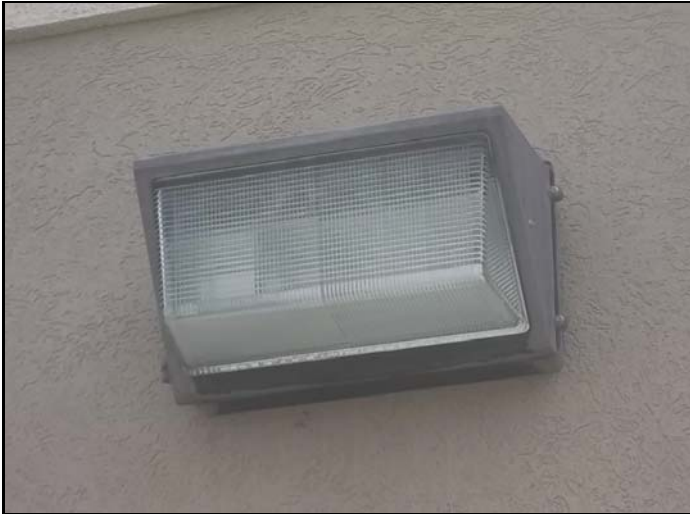
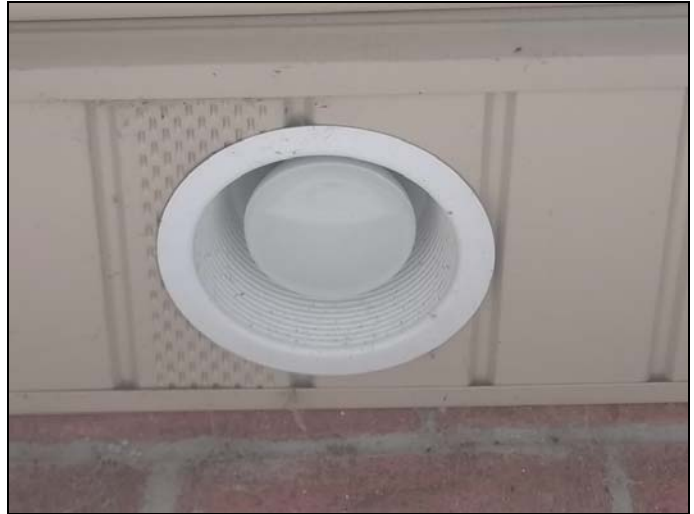
Comp #: 1602 Exterior Light Fixtures - Replace

*Location:* **Building Exteriors**

The exterior light fixtures are in good to fair condition. We recommend funding to replace this component approximately every 16 - 20 years. Remaining life based on current age.

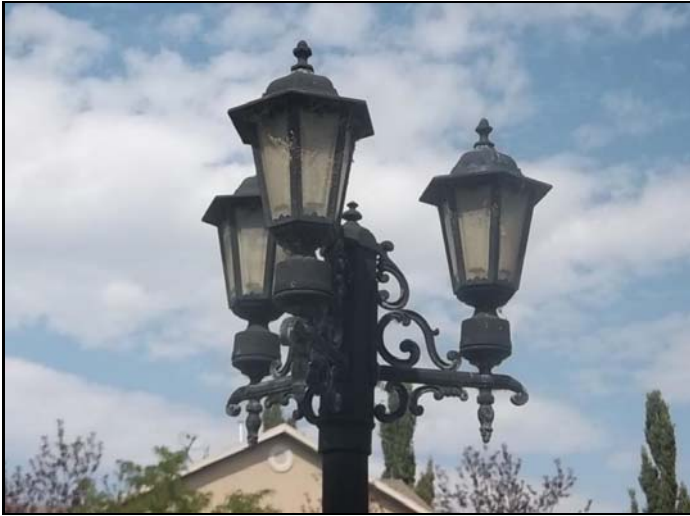
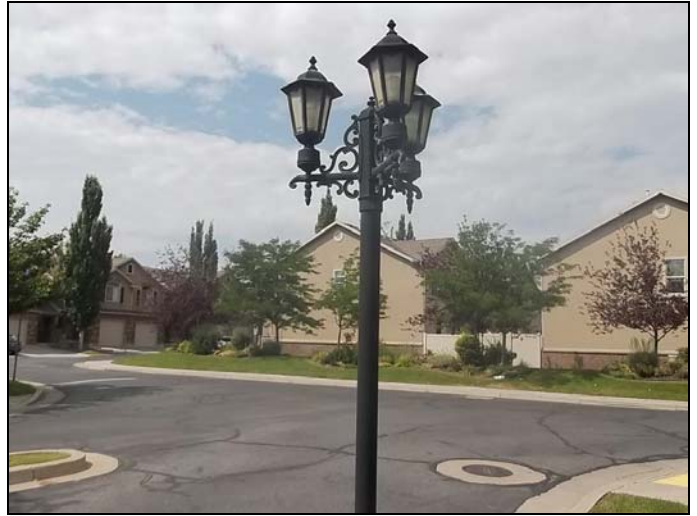
Comp #: 1604 Pole Lights - Replace

*Location:* **Common Area**

The pole lights are in fair condition. We recommend funding to replace these pole light fixtures, poles and to refurbish the electrical approximately every 16 years. Remaining life based on current age.

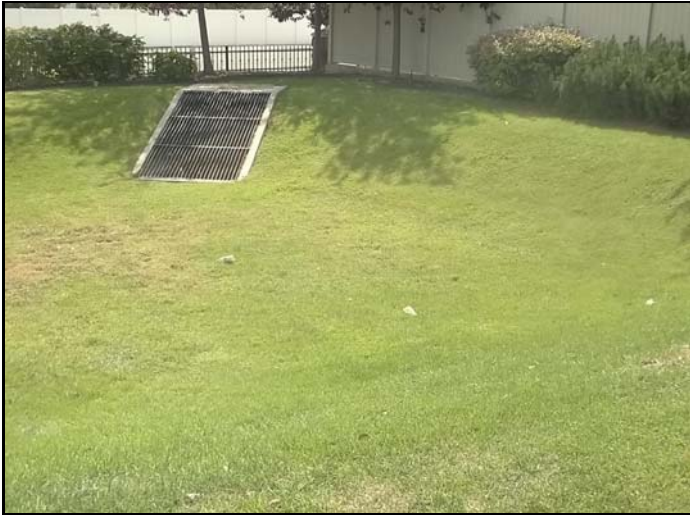
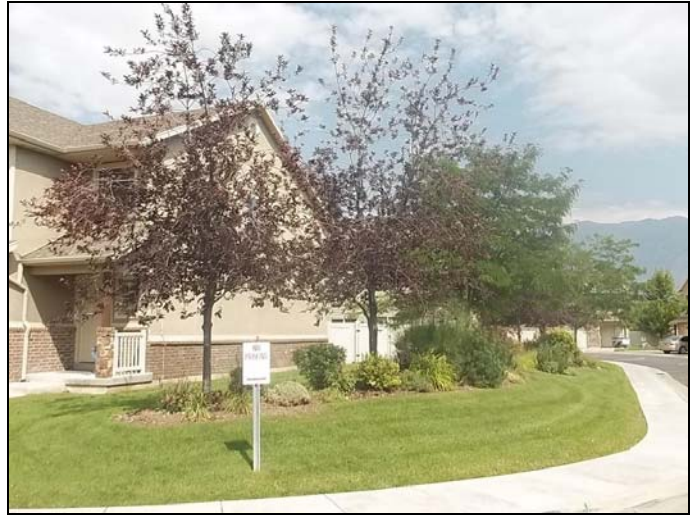
Comp #: 1812 Landscaping & Irrigation System - Renovate

*Location:* **Common Area**

Research with the client reveals plans for tree replacement in 2019 and irrigation system major work in 2021. We recommend funding for an allowance to renovate the landscaping and irrigation system approximately every 20 years. Remaining life based on current age.
